Contamination of Soil due to Leakages of Polychlorinated Biphenyls (PCBs) at a Vandalized Electrical Transformer Site

Nedzamba R M and Gumbo JR

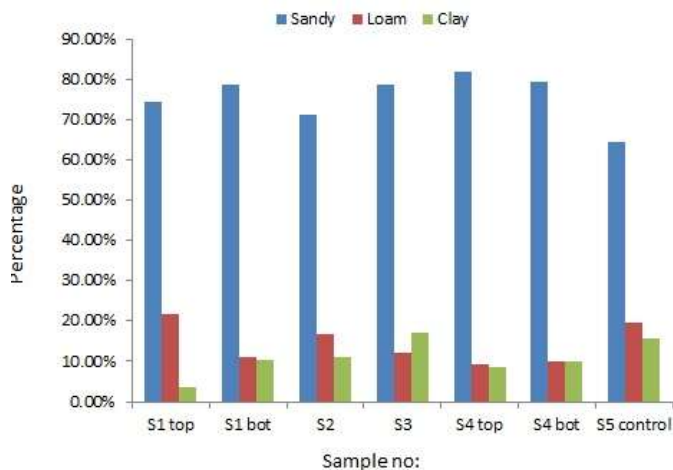
The soil type of the study area was found to be sandy because the sandy particles were 65 – 82% in the samples, loamy particles were about 9 – 22% in the soil samples and clay was about 4 – 17% in the soil samples (Figure 2). Therefore the soil of the study area was sandy since larger quantities of particles are sandy.

Fig 2: Particle size graph showing the amount of sandy, loamy and clay soil in the study site.

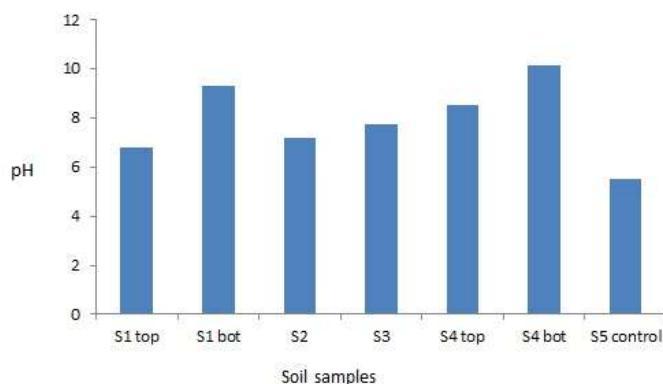
The pH of the samples varied from sample to sample, pH ranged from 6.79 to 10.15 (Figure 3).

Fig 3: Soil pH. This is the pH of each sample from S1 Top to S5 Control.

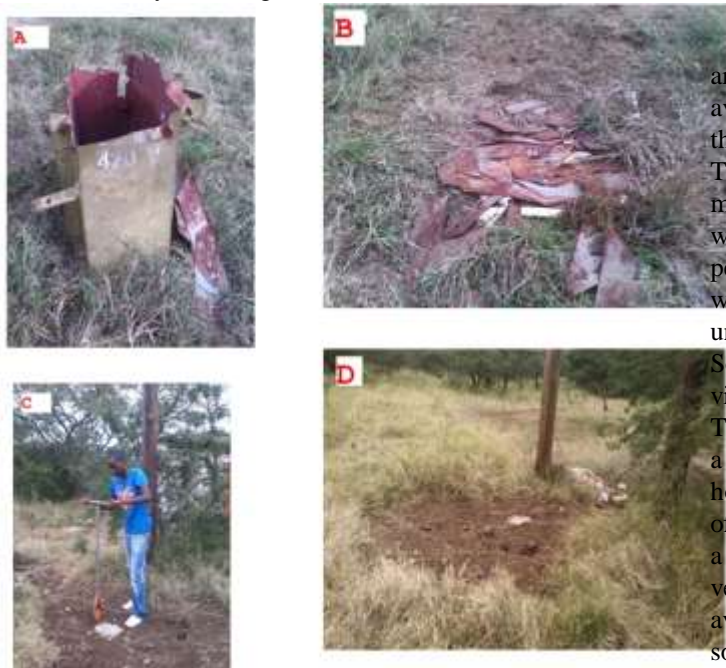
The samples were collected from the site where the transformer contents were leaked to the ground after when the transformer was damaged by thieves (Figure 4). The results showed that there were ultra-trace levels of PCBs which were less than 0.01 mg/kg. The absence of PCBs at the surface may be because they have migrated downwards.

Fig 4: (A) The vandalized transfer that was damaged by the thieves, (B) the contents of transformer were thrown into the ground, (C) collecting of samples from the contaminated site and (D) notice there is no grass growing at the contaminated site

During the sampling process at 20 cm we encountered hard bed rock such that we were unable to penetrate beyond this point. A group of first samples were taken to SABS in Pretoria and were analysed there and the results that were found were less than 0.01 mg/kg. A second group of samples were taken to Waterlab in Pretoria and the results found showed that the amounts of PCBs in all samples were less than 0.01 mg/kg or below the limit of quantitation in all Arochlor (Table 4).

At the contaminated site there was no grass that was growing and this may be due to the ultra-trace levels of PCBs that may have inhibited their growth (Figure 4D). The study of Streck et al. [22] has shown that the presence of PCBs in the soil can interfere with the growth of plants when they are applied at higher concentration. Streck and Weber [23] noted
