EVALUATION OF STRATEGIES FOR REHABILITATION OF SELECTED ABANDONED/HISTORIC MINE SITES IN THE GIYANI GREENSTONE BELT, LIMPOPO PROVINCE OF SOUTH AFRICA

**A Dissertation Submitted to the Department of Ecology and Resource
Management, School of Environmental Sciences, University of Venda
in Fulfilment of the Requirements for Master of Environmental
Sciences**

September 2020

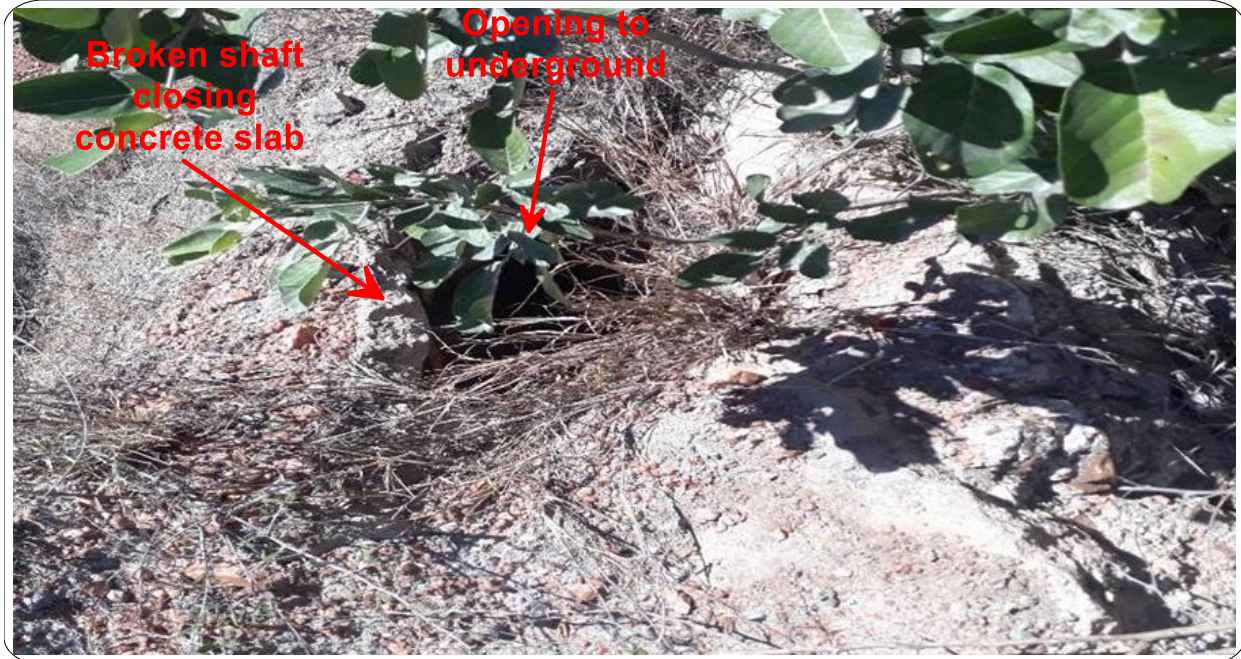
The case in Louis Moore Mine illustrates this kind of a situation. The risks observed at Shaft-A in Louis Moore are linked to the deterioration of the sealing structure at the shaft head (which is the timber platform). There were three situations that were observed about the shafts that were closed with timber platform. Firstly, the wooden platform was found deteriorated, thus leading to a possibility of failure of the timber platform. Failure of the decayed wooden platform can be attributed to the subjection of the platform to excessive loads or when surface material ground on which they rest fail (Lecomte *et al.*, 2014).

In the second case, the timber was concealed by years of vegetation growth (see Figure 4.3) such that the shaft was extremely difficult to identify. This may pose serious threats to people and animals that frequently visit or move around the site. These people and animals may fall into the mine shaft. Consequently, this may lead to death due to physical body injuries and drowning in water that is contained in the mine workings (Wrona *et al.*, 2016). According to Rembuluwani *et al.* (2014), the occurrence of water in a shaft can induce the creation of voids which may destabilize the lining of the shaft, resulting in its collapse.

Figure 4.3: An illustration of the shaft covered with a deteriorated concrete slab and timber platform at Louis Moore Mine.

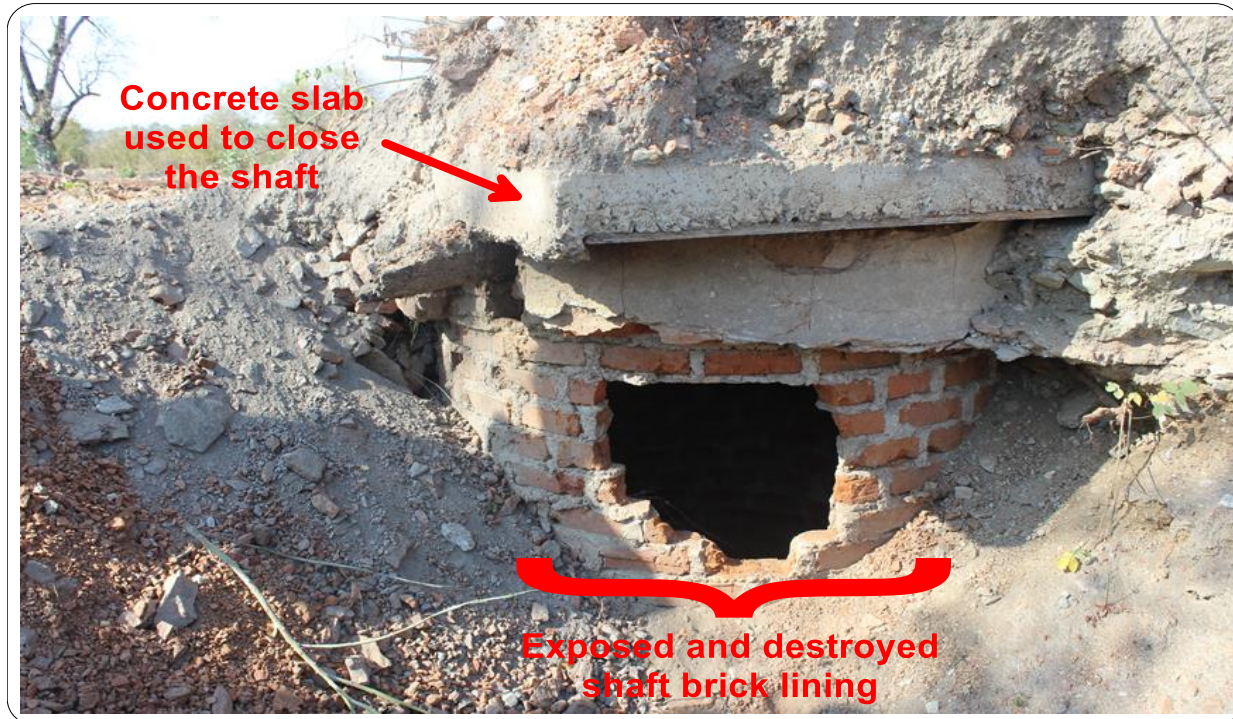
There were three scenarios observed from Shaft-B. The first one is the fact that, the artisanal miners managed to break the shaft lining which was constructed using bricks (see Figure 4.4). According to Steenkamp and Mostert (2012), the breaking of the mine shaft lining was done in order to gain access to the underground mine workings where they mined the remnants of the ore. This unscrupulous act by artisanal miners created a big hole on the shaft lining. Secondly, the shaft was closed using a single on-surface or

near-surface concrete leaving the whole column empty, hence susceptible to cave in. Thirdly, the ground around the collar/entrance of the shaft was unstable; as the artisanal miners have dug all the supporting material around the collar of the shaft. This was evidenced by the diggings that were observed around the shaft.

Figure 4.4: An illustration of the shaft lining destroyed by illegal miners.

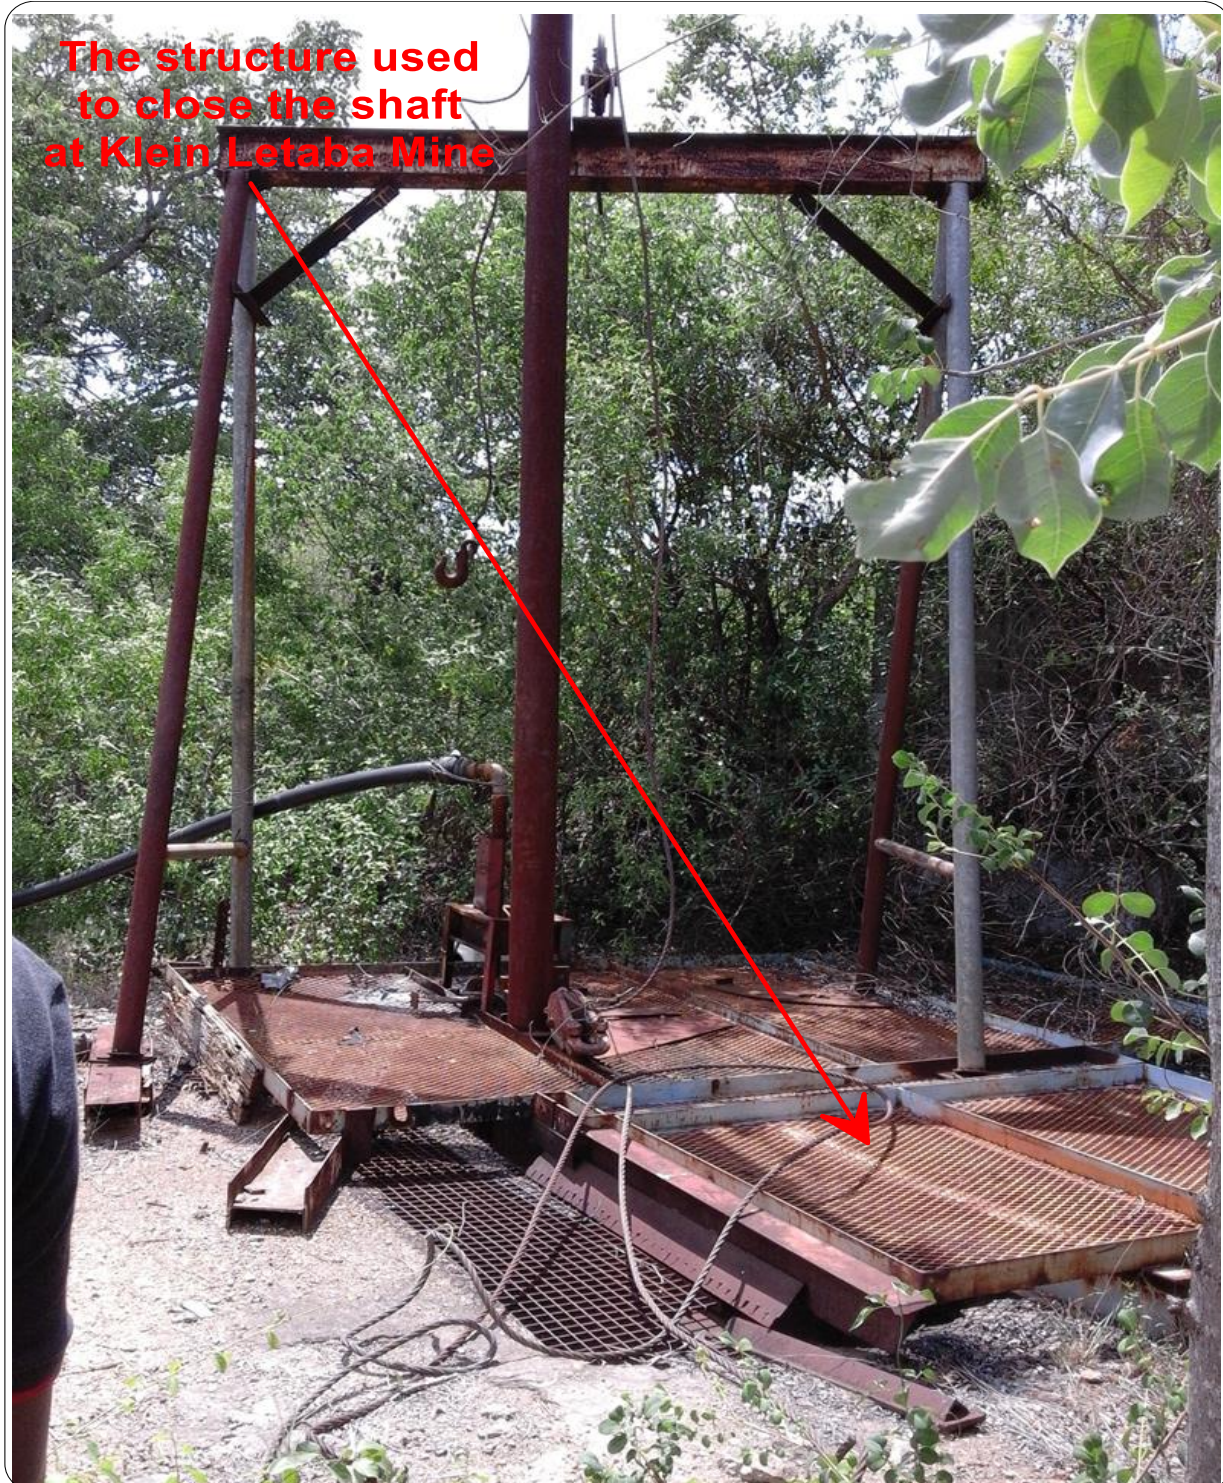
One shaft at Klein Letaba Mine was found closed with galvanized steel gate as shown in Figure 4.5. Two scenarios were observed from this shaft. The first is that the structure used to close the shaft was no longer in contact with the ground to which it was mounted. The structure has potential to fall or shift and this may lead to the shaft not being properly closed. This may result to physical injury to anyone climbing on or walking around the structure. Secondly, the shaft was used to pump underground water for different purposes such as irrigation and domestic use. According to Mhlongo *et al.* (2018), the pumping of water from the underground mine workings can cause an upward migration of contaminated groundwater. Thus, this shaft has a relatively high potential of discharging contaminated and acidic water to the environment.

Figure 4.5: An illustration of mine shaft closed with steel structure at Klein Letaba.

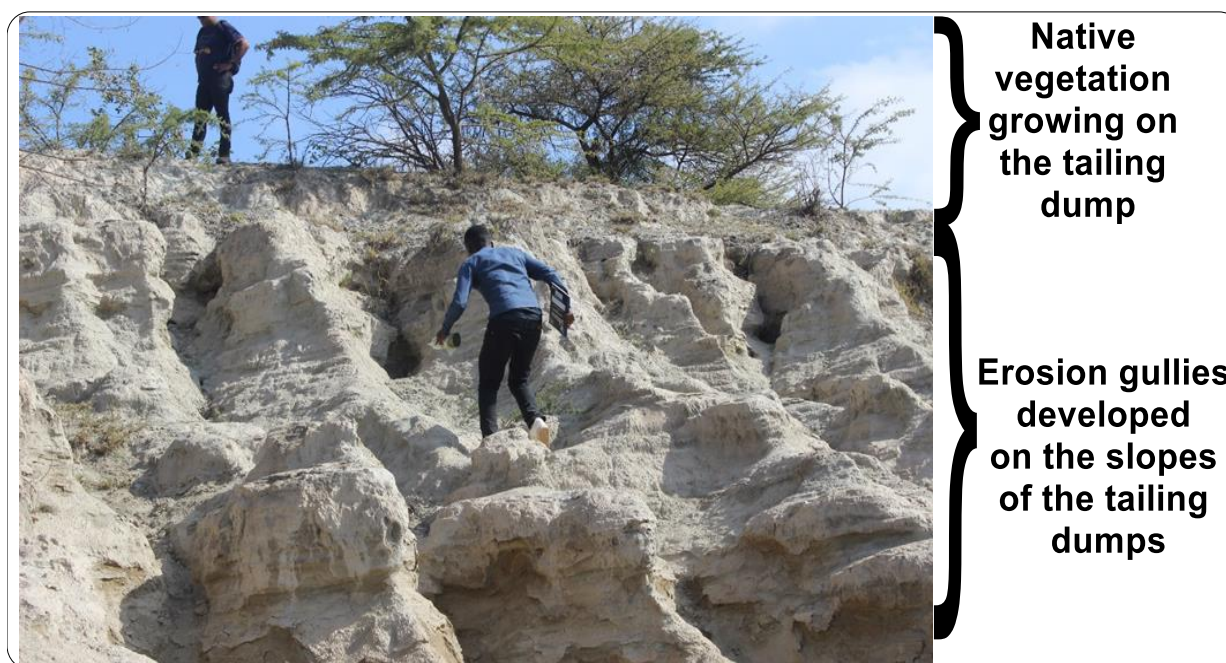
and animals that frequently walk around the dump. The severity of the erosion is high and a probability of erosion occurring again is also high due to the rainwater and wind action. There is evidence that crest walls were used to virtually eliminate erosion on both tailing dumps. Crest walls also prevent precipitation on top of the dumps from cascading down the outer slopes, thus the increased erosion on slopes (Blight, 1989). The horizontal top surface of these tailing dumps was found to be relatively little-affected by erosion. The tailing dumps at Louis Moore Mine are designed in two benches, with lower bench and upper bench height ranging from 5-10m and 10-15m respectively.

Figure 4.6: Evidence of growth of vegetation on the top surface and devastating effects of gully erosion on the slope of tailings.

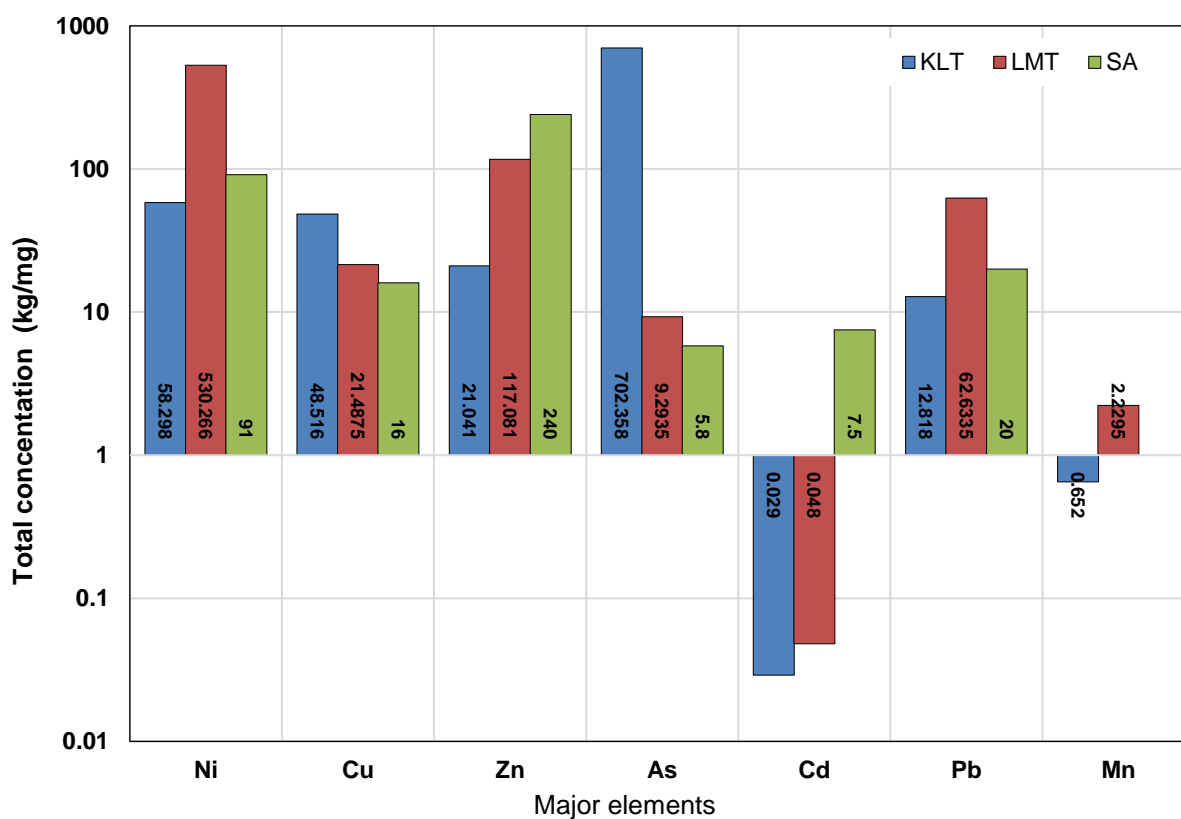
Louis Moore and Klein Letaba tailings were also dominated by Pb, Mn, and Cd. Cd and Pb that are generally carcinogenic and prolonged exposure to low concentrations could lead to kidney disease, lung damage, and fragile bones for Cd, and nervous disorder in the case of Pb (Gashi *et al.*, 2016).

Figure 4.7: Metal concentration in tailings materials at Louis Moore and Klein Letaba mines.

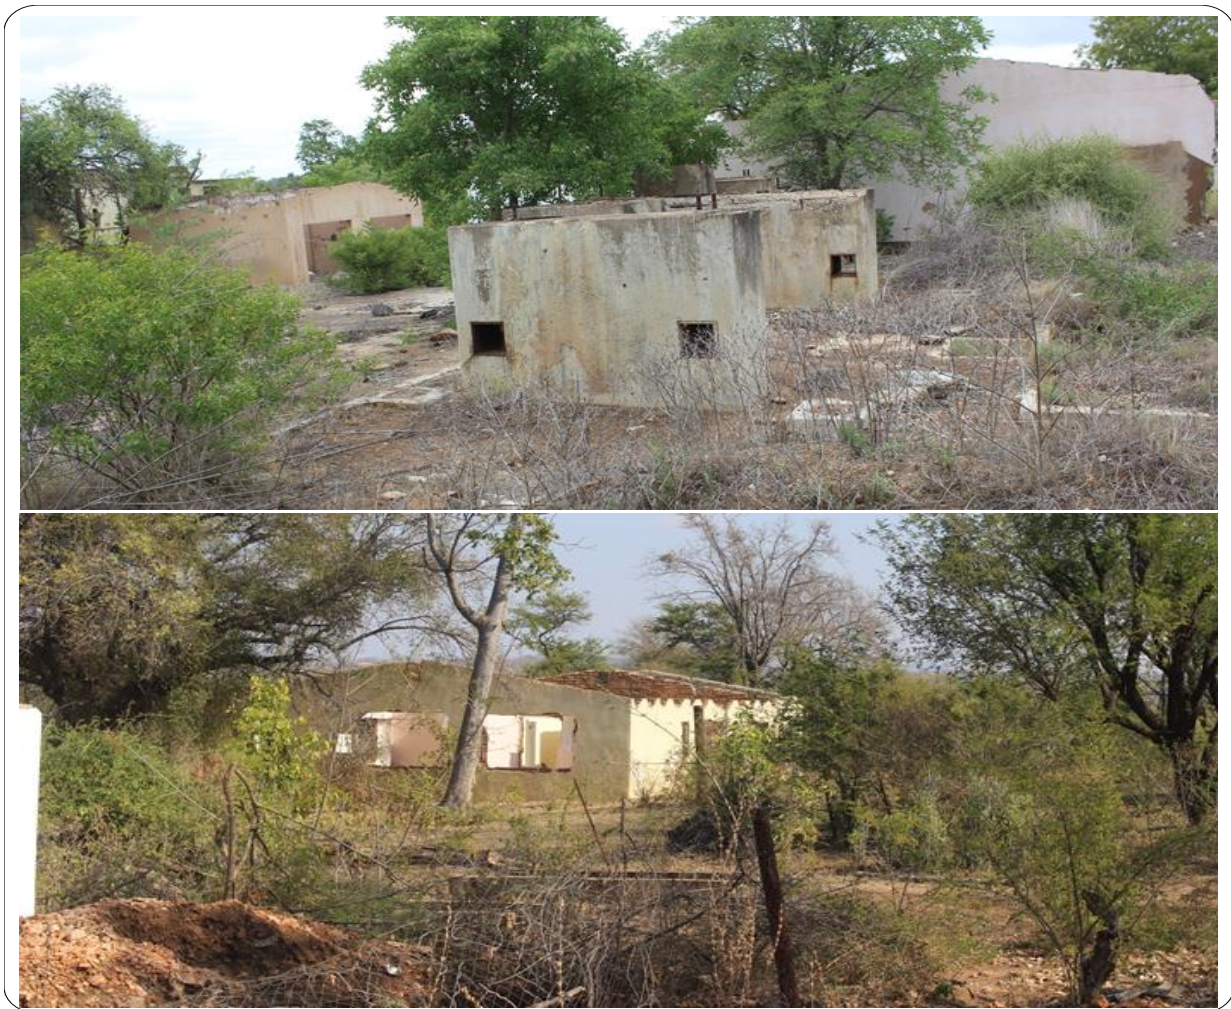
serious hazards to both people and animals. Other features such as cemented/paved floor or foundation of the completely demolished buildings were observed at both sites. Deteriorated foundation of the building may suddenly weaken and the entire building may collapse anytime without warning and cause injuries or fatalities.

The conditions of the structures coupled with illegal mining activities present serious physical hazards which may include fatal injuries to people and animals. In addition, these buildings pose socio-economic concern to community members because they have become a hiding place for thieves and from the surrounding communities. Furthermore, Impacts associated with vandalizing these structures includes the destruction of buildings that may have had some historical significance.

Figure 4.9: An illustration of vandalized abandoned building at Klein Letaba Mine.

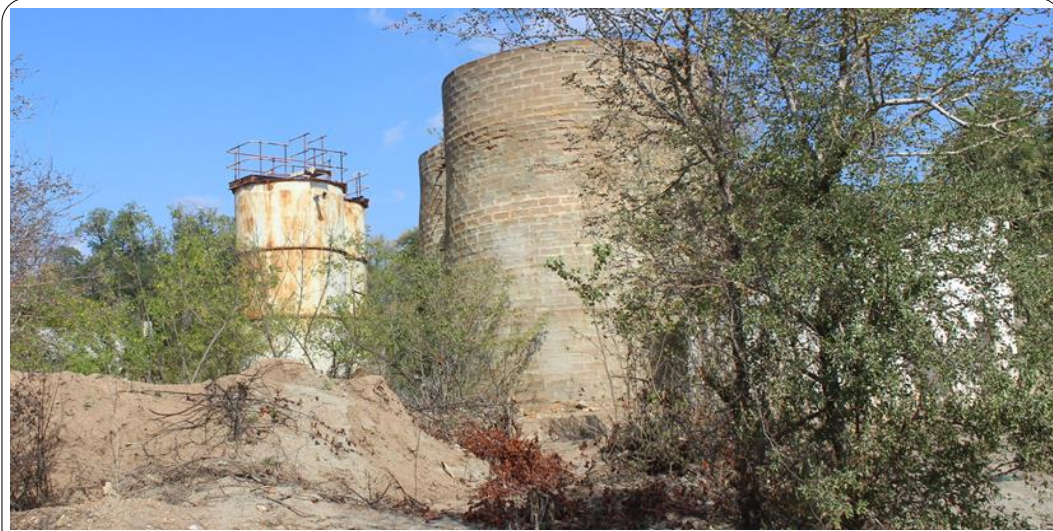
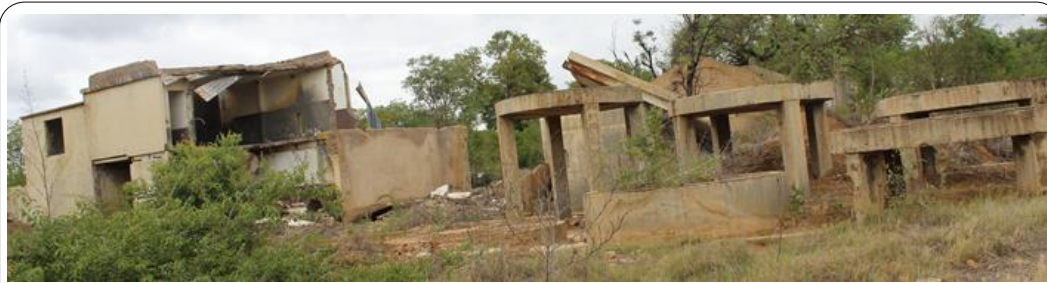
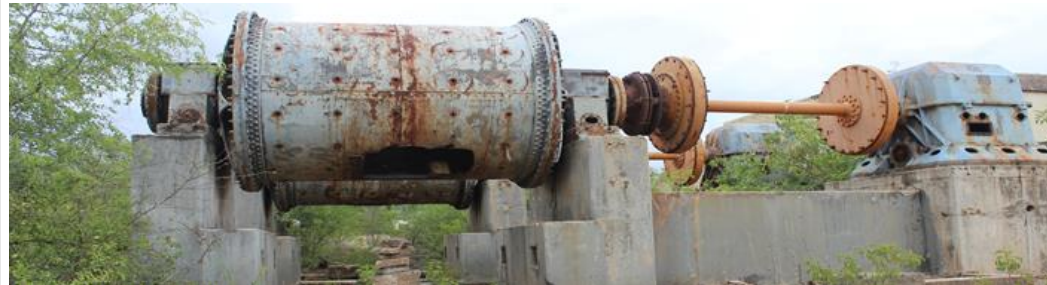
Figure 4.10: Dilapidated mineral processing plant at the study area.

Field survey conducted during the study revealed that there are dilapidated processing plants and ore storage facilities such as silos at Klein Letaba and Louis Moore abandoned mine sites. Figure 4.10 is an illustration of one of the silos and wrecked processing plant at Klein Letaba Mine. The silos at both sites were found to be in a cylindrical shape and are about 6m to 20m high above ground level. Also found at the two mine sites were concrete stands to support agitation tanks. The agitation tanks which were supported by a 3m concrete stands were estimated to be 6m in diameter and 12m high.

These structures are believed to have attracted artisanal mines. This is because the illegal miners dug around them with the aim of recovering the remnants of the gold ore. The spillage from the abandoned structures has a potential of causing public health and environmental hazards since it can result in soil contamination around the processing plant. The area around the mineral processing plants was found to be unstable due to excavations made by the artisanal miners. Over time, these structures can be detached from foundations, thus the potential to fall or shift causing injury to anyone climbing.

Mineral processing plant at Louis Moore Mine

Mineral processing plant at Klein Letaba Mine

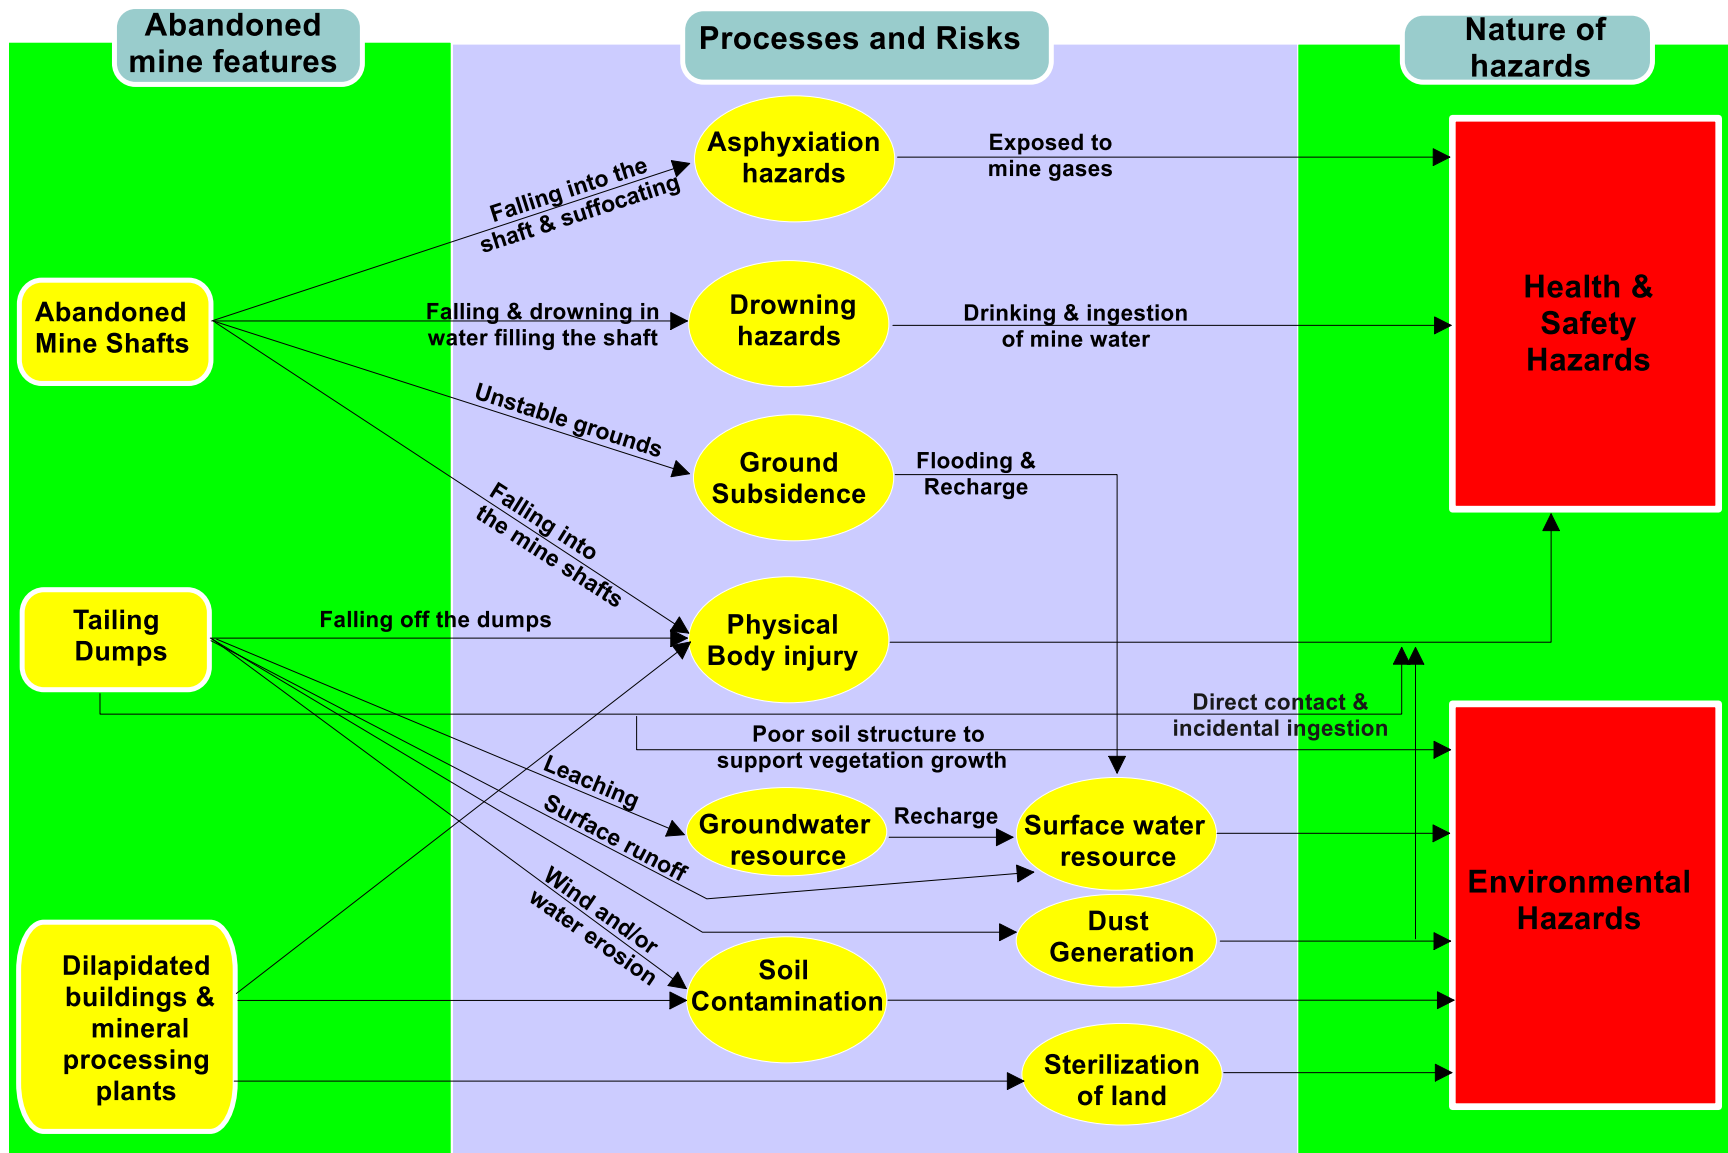
The dilapidated buildings and processing plants presented the physical hazards which included the risk of physical body injury with potential accident points where suspending debris or the whole building can fall on passersby/trespassers, junks and thrashes can contain sharp objects that can injure residents in the neighborhood. Other environmental

hazards related to neglected buildings and processing plants included the risk of soil contamination and soil texture modification leading to plant community changes in the area and land sterilization since the land cannot be used for development.

Figure 4.11: Conceptual model representing abandoned mines.

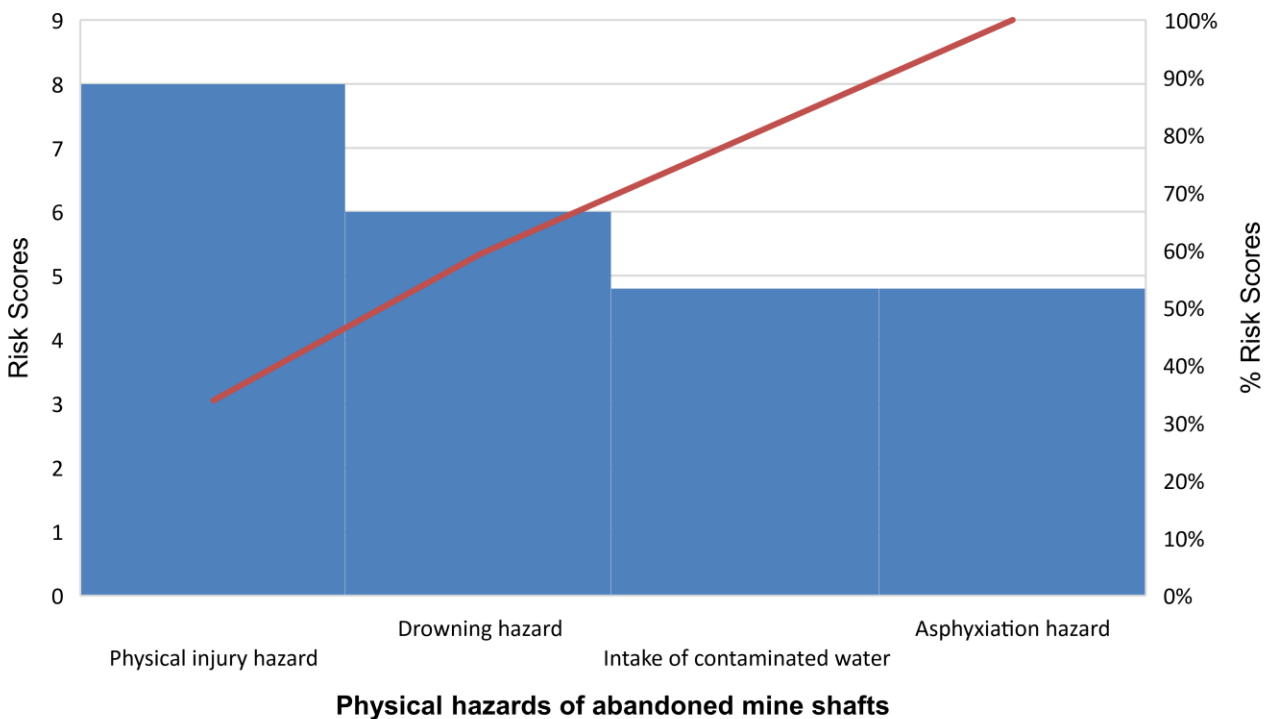
to toxic gases inside the shafts. These risks can be a consequence of people accidentally falling or voluntarily entering the shaft.

Figure 4.12: The physical hazards scores for abandoned mine shafts.

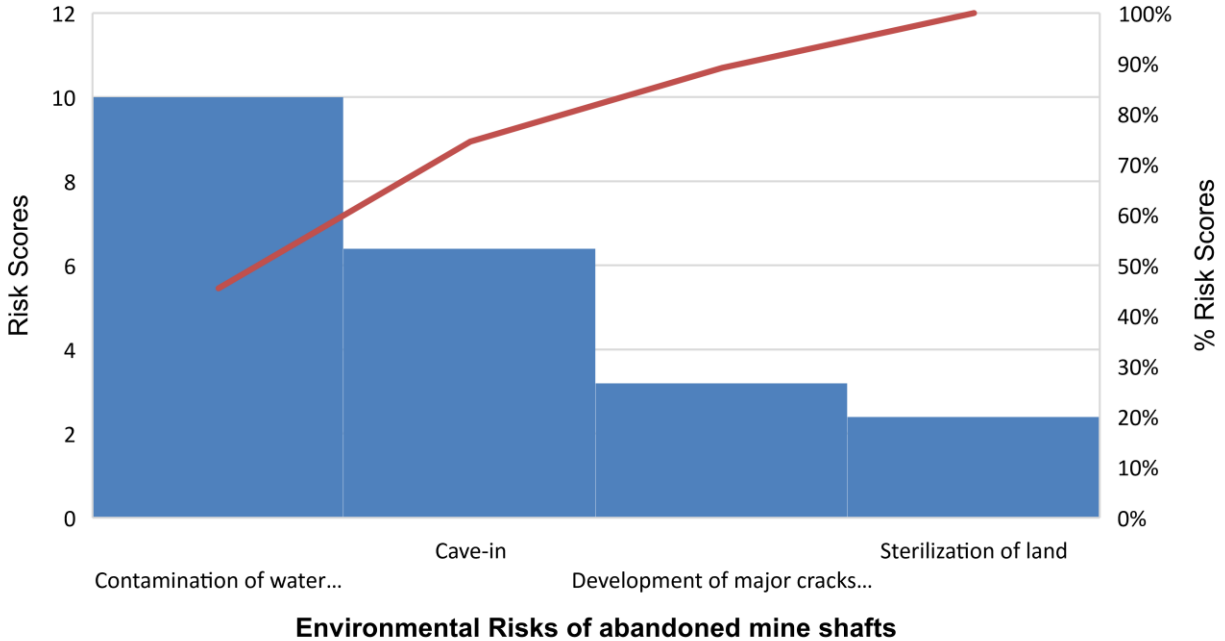
The results of scoring for environmental hazards portrayed contamination of water resources at Klein Letaba River as the highest hazard due to ground subsidence. Contamination of water resources emerged as the most serious concern with the highest environmental hazard score of 10 as shown in Figure 4.13. This is because ground subsidence has a relatively high potential of contaminating groundwater and surface water recharge, which can be caused by flooding. Consequently, this poses a serious threat of decimation of aquatic life and vegetation lands in the proximity of 3 ha in the area. The second highest environmental hazard was the cave-ins which was scored 6.4 as shown in Figure 4.13. The risk of cave-in can be caused by the unstable grounds around the shafts since there were diggings that were observed around the shafts, mostly at Louise Moore. This was followed by the risk of the development of sinkholes and major cracks due to water entry. Sterilization of land due to subsidence was scored as the lowest environmental hazard but this prevents land use for development.

Figure 4.13: The environmental hazards scores for abandoned mine shafts.

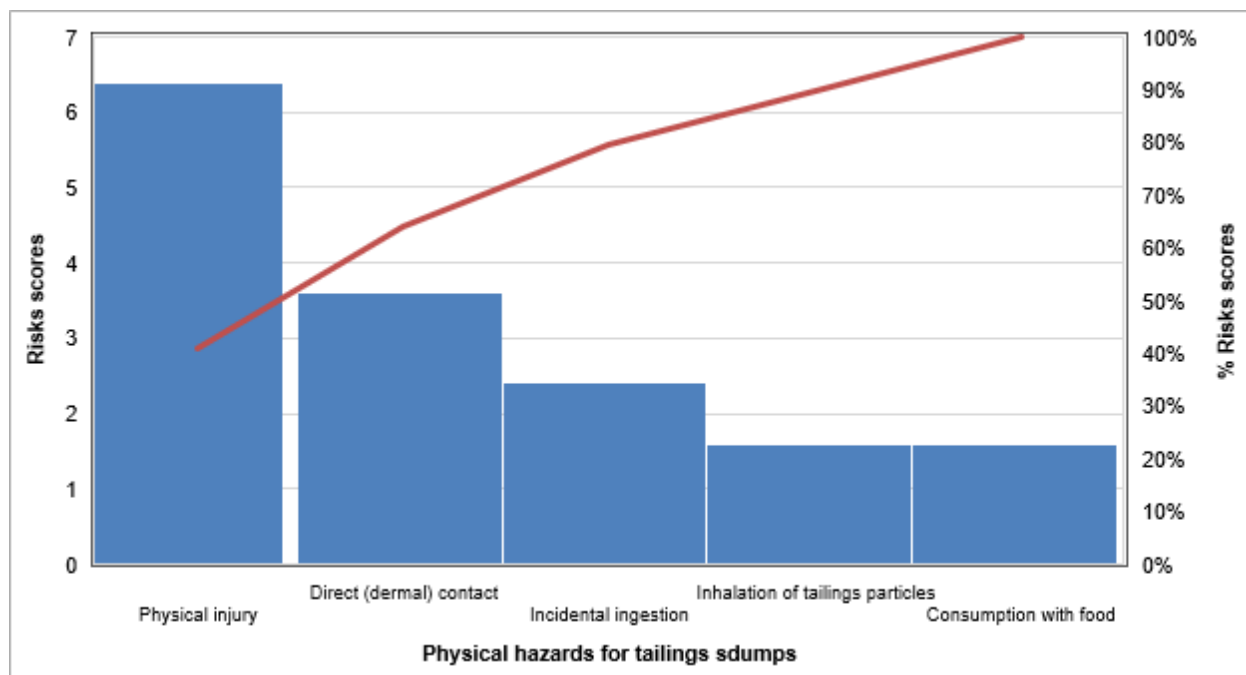
and the lowest score hazards were the risk of ingestion of contaminated water and the risk of consumption of contaminated food.

Figure 4.14: The physical hazards scores for tailings dumps.

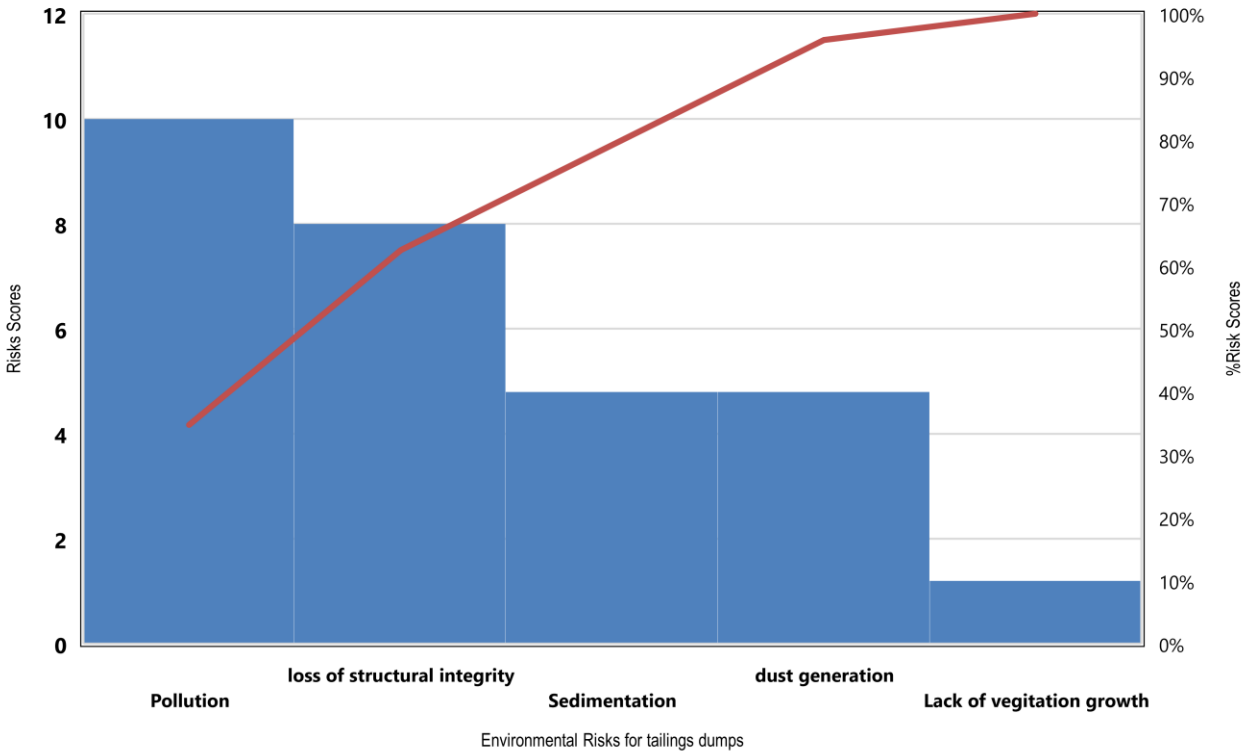
The scoring of environmental hazards of tailings dumps showed that the dumps have high risks of pollution which was scored 10 as shown in Figure 4.15. The exposure of tailings dumps can facilitate the erosion which contributes to extensive spatial dispersion of tailings particles. This can also result to surface runoff to nearby water bodies, bearing in mind that the tailings dumps are very close to the major rivers in the Giyani area. In view of this, the tailings dumps had the highest environmental hazard score since they have great potential of polluting water resources in the study area. The second highest environmental hazard was the loss of structural integrity of the tailings dumps as a result of water erosion. This was then followed by sedimentation and dust generation due to wind erosion. Sedimentation can be a result of tailings dumps particles carried to low lying areas and/or rivers through surface runoff, later resulting in the destruction of habitat for aquatic species and thus disrupting the natural ecosystem. The lack of vegetation growth due to the poor structure of tailing dumps was also identified as one of the environmental concerns of the tailings dumps in the study area.

Figure 4.15: The environmental hazards scores for tailings dumps

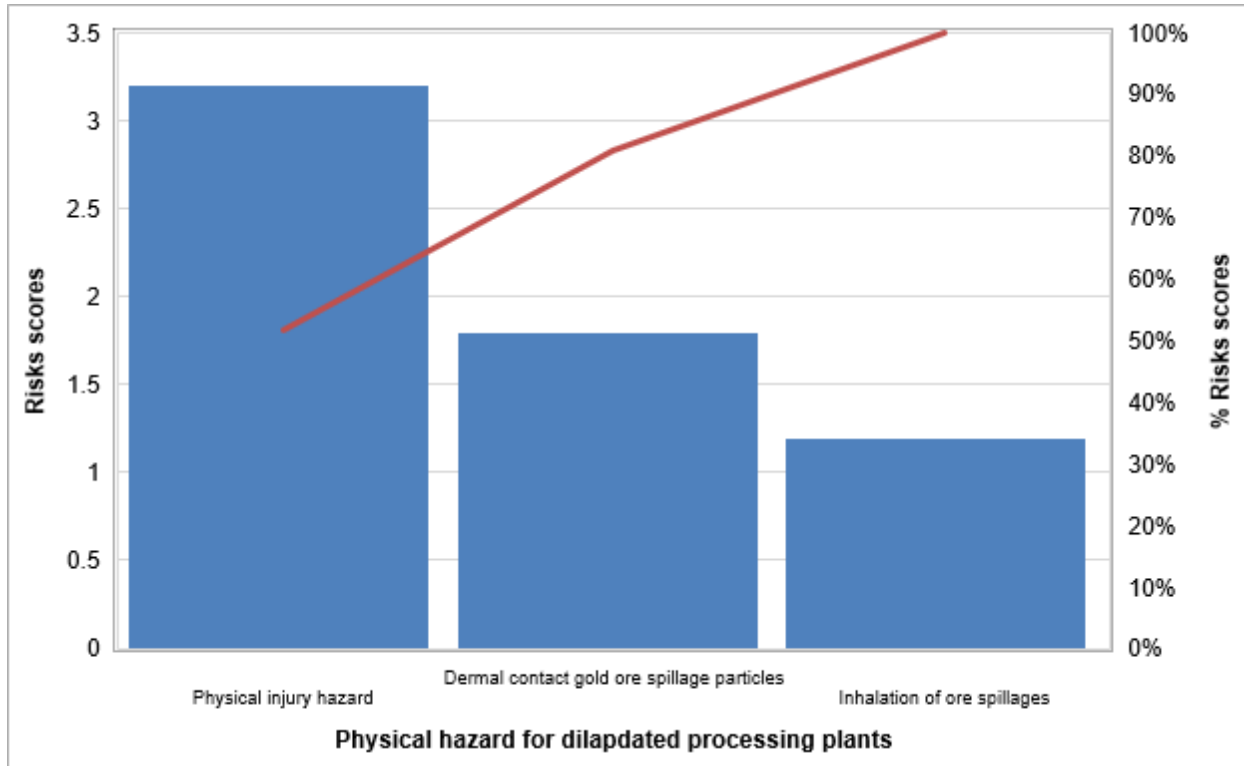
Figure 4.16: The physical hazards scores for abandoned dilapidated processing plants

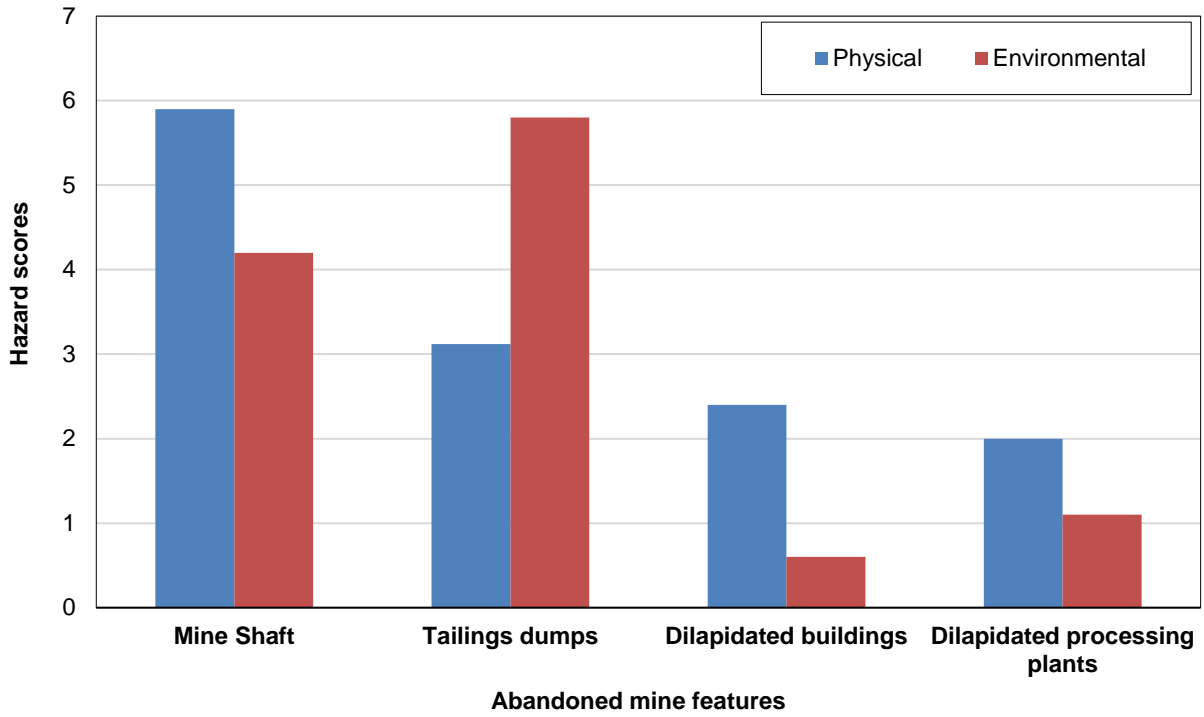
The physical hazards associated with abandoned processing plants such as physical body injuries can be caused by collapsing of the processing plant without warning. The area of the processing plants was found to be unstable, due to diggings that occurred in their surroundings. However, the environmental hazards score for the processing plant was associated with risks of soil contamination by heavy metals resulting from the spillage of gold mine ore. The dilapidated mine buildings were found to have the lowest physical hazards score of 2.4 and the environmental hazard score of the buildings was 0.6. these results have been shown in Figure 4.17. The dilapidated buildings in the study area had cracked and unstable walls and these pose safety threat to people and animals who move around the study area. The buildings also present serious aesthetic impacts to the site due to the way and manner these buildings are dotted in the study area.

Figure 4.17: Physical and environmental hazards of abandoned mine features

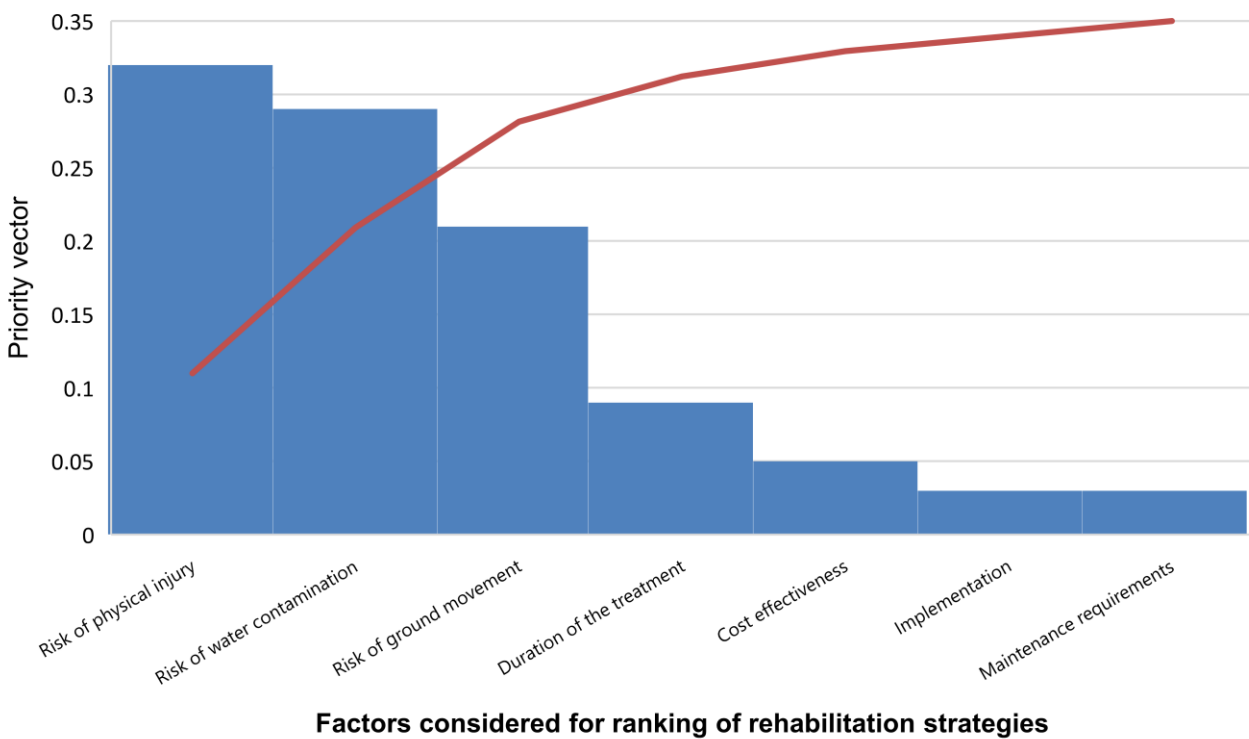
The durability of the strategy was ranked as the fourth factor. The main reason for prioritizing the durability of the strategy for rehabilitation of abandoned mine features is that the selected action may require less maintenance, thus saving cost of maintenance of rehabilitation strategy. This was then followed by the issues of addressing the cost-effectiveness of the strategy with the score of 0.04. The least important factors to consider were the implementation and maintenance requirements. Each of these factors has a score of 0.02. The very low score for implementation and maintenance requirements may be due to the fact that these factors normally do not have a direct impact on physical (health and safety) and environmental hazards identified in the study area

Figure 5.1: The rank of the factors for selection of rehabilitation strategies for abandoned mines

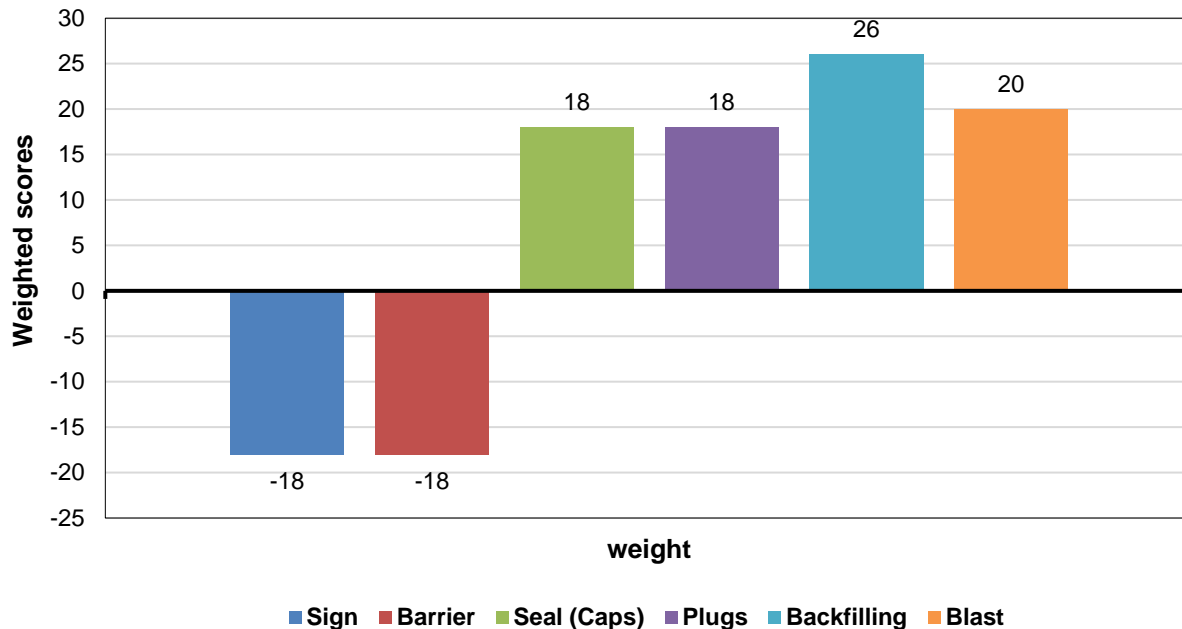
Figure 5.2: The ranking of rehabilitation strategies for abandoned mine shafts.

The least preferred options for dealing with the issues of abandoned mine entries included barriers and signage. Barriers and signage rehabilitation strategies are temporary measures that can be implemented to reduce the hazards of abandoned mine openings prior to the implementation of a long-term strategy. Both options restrict access to the study area but do not completely eliminate the possibility of entry into the mine openings. However, both options were preferred since they are the least expensive and easy to implement.

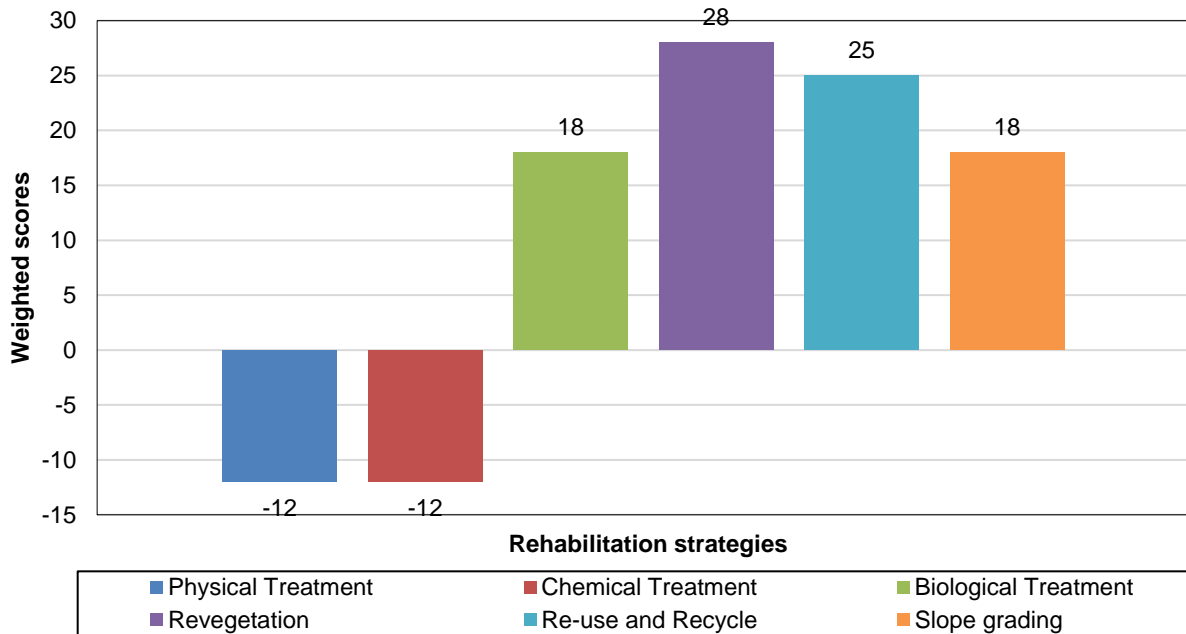
Figure 5.3: The ranking of rehabilitation strategies for abandoned tailings dumps.

The least preferred rehabilitation strategy included re-use and recycling, chemical and physical treatments. The re-use or recycling of materials is an effective means of eliminating contaminants and have the potential of reducing environmental and physical impacts after implementation. According to Lottermoser (2011), provided that it is chemically non-reactive, mine waste can be used in various ways outside the mine environment. Solid mine waste (overburden, waste rock, solidified tailings, slag, dust) can be used as backfill in underground or open pit workings. The cost of re-use or recycling may range from profitable to high depending on the cost of the re-use or recycling minus the value paid for the metals or other materials. Chemical treatment may require significant costs for the operating and maintenance over the life of the remediation. Physical treatment can be used as a short-term interim measure since it does not completely address the physical and environmental impacts of abandoned mines (Ceto and Mahmud, 2000). Installation of a cap or cover on solid mining waste can reduce or eliminate erosion, dust emissions, and infiltration of water to prevent the migration of contaminants. The Maintenance costs of physical treatment such as the cap could be significant, particularly if the cap or cover can be easily damaged.

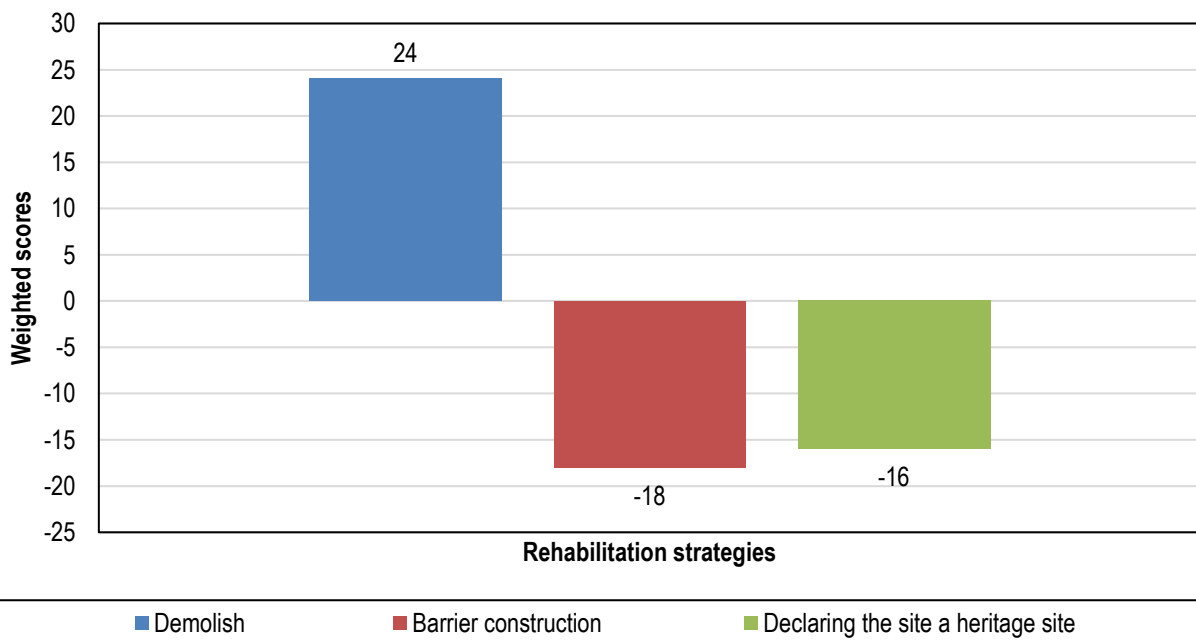
Figure 5.4: The Selection of rehabilitation strategies for dilapidated buildings and processing plants.

into a tourist attraction site. Regular inspection and maintenance will be required. This option takes advantage of existing infrastructure and contributes to the local economy after the mine has been closed. The least preferred option for the rehabilitation of abandoned mine buildings was barrier construction. It was preferred in terms of duration and cost-effectiveness. However, regular maintenance would be required. Barrier construction option can be adopted as a temporary measure prior to the implementation of a long-term strategy. Since this option only restricts access to the site but do not completely eliminate the possibility of people moving around the dilapidated buildings and does not completely address the physical and environmental impacts of the abandoned mine site. However, both options were preferred since they are the least expensive and easy to implement.
