**DEVELOPMENT OF AN INTEGRATED APPROACH FOR
PRIORITIZATION OF MINE FEATURES OF SELECTED
ABANDONED MINES FOR REHABILITATION IN THE GIYANI
GREENSTONE BELT**

**A Dissertation Submitted to the Department of Earth Sciences, Faculty of
Science, Engineering and Agriculture, University of Venda in Fulfilment of
the Requirements for Master of Earth Sciences in Mining and
Environmental Geology**

September 2022

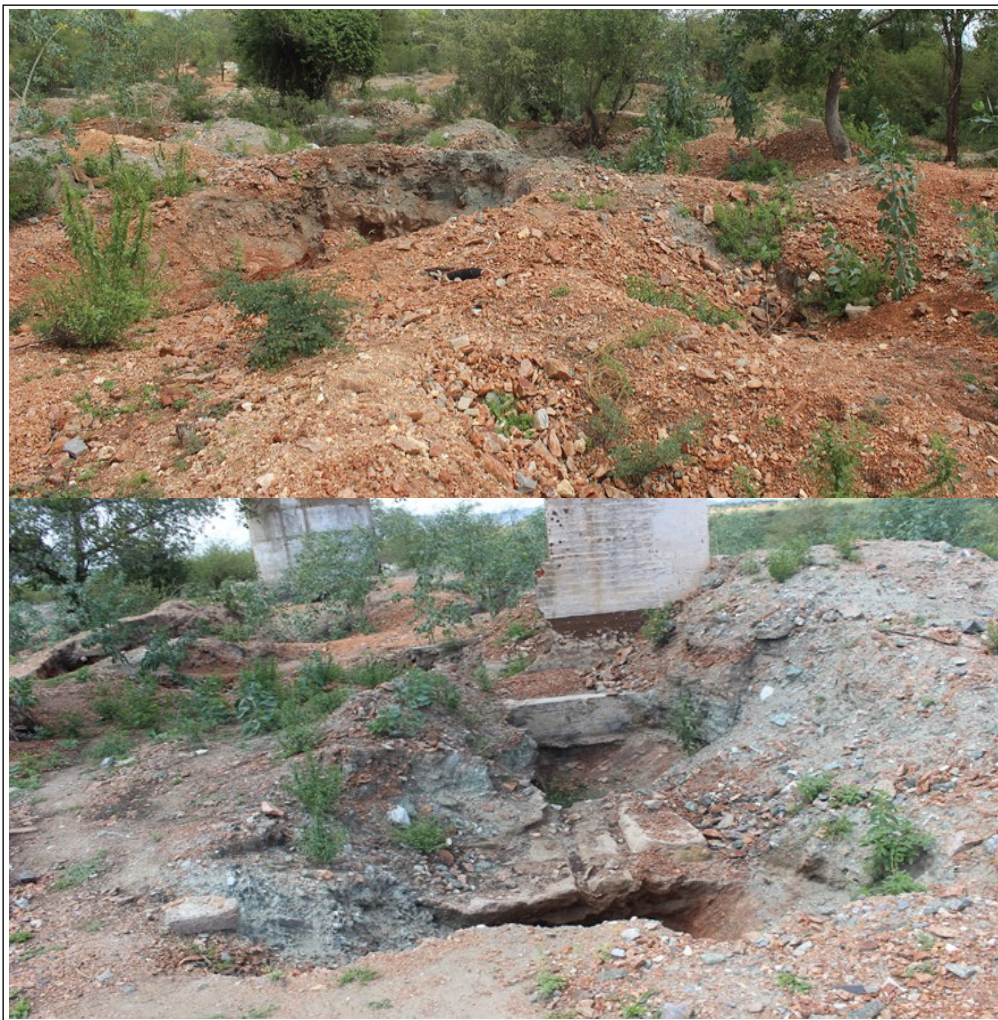
camouflaged by vegetation growing on and around them. These pits are prone to flooding during rainy days, and this might expose people, especially children and animals, to risks of physical injuries or even death due to drowning if they trip and fall into the flooded pits. On the other hand, impounded water in the pits may be alkaline or acidic due to toxic elements resultant from previous mining activities thus capable of causing skin problems. A huge opening that is approximately 10-15m deep was identified at Klein Letaba. Hazards identified to be associated with the opening include falling into the opening, sharp objects covered by rocks and soil in the opening can cause severe physical body injuries and can be fatal. Furthermore, the major environmental impact identified and linked to this opening was land degradation since a large portion of land was disturbed and degraded.

Figure 4. 3: Land degradation due to artisanal gold mining activities at Louis Moore Mine

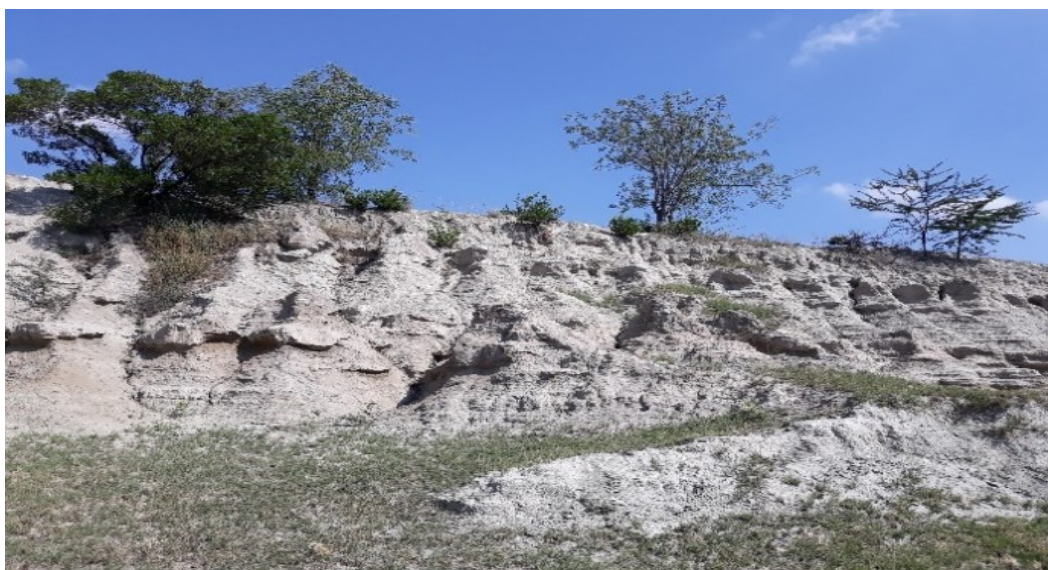
the embankment and lead to instability of part of the slope. This clearly suggests that gully erosion on the slopes of tailings dumps is associated with visual and environmental impacts.

Figure 4. 4: The evidence of devastating effect of erosion on the slopes of the tailings dumps of Louis Moore

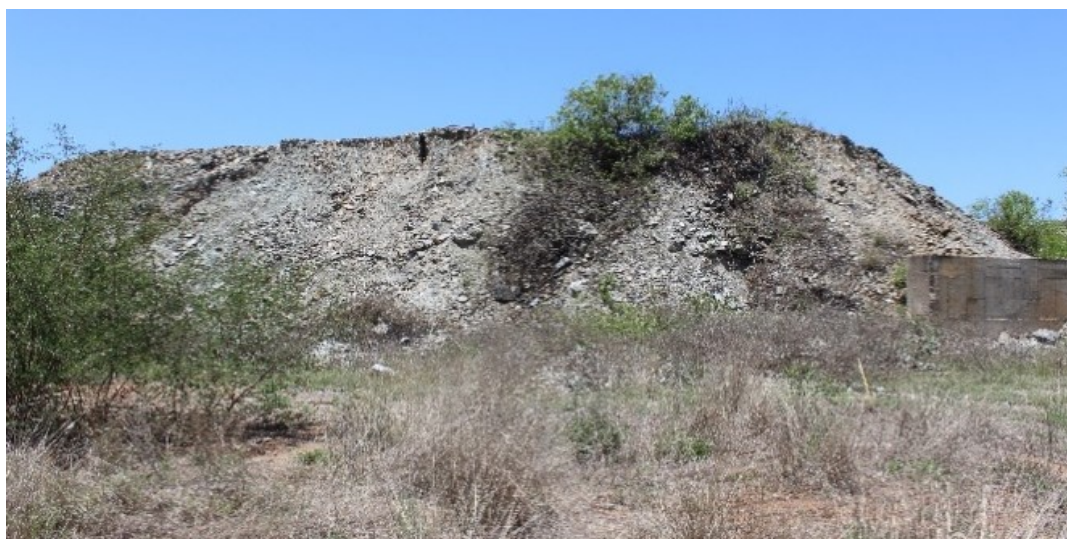
Maximum concentrations of As, Co and Ni within the rock dump samples in Klein Letaba were more than 12 times higher than the Abundance of Elements in Average Crustal Rocks (AEACR) of 2.30 and 75 mg/kg respectively as recommended by Taylor (1964). Cu, Zn, Cd, Pb and Co concentrations were lower than the AEACR standards. This suggested that the rock dumps are highly enriched in As, Co and Ni indicating high contamination by these metals. A similar study conducted by Gbadebo and Ekwue (2014) in Southwestern Nigeria showed high concentrations of Cd, Pb, Zn and Cu when compared to the AEACR standards. This could be due to the natural/ geogenic occurrence of the major host rocks. Contaminants in mine wastes may affect human health and may lead to the impairment of drinking water and other water resources by natural leaching transport and sediment transport (EPA, 1998). According to DMR (2009), one of the biggest negative impacts of abandoned mines is that a significant portion of South Africa's land is locked up in mine dumps which turn to affect the economic development of where these dumps are found.

Figure 4. 5: A relatively small waste rock dump in Klein Letaba Mine

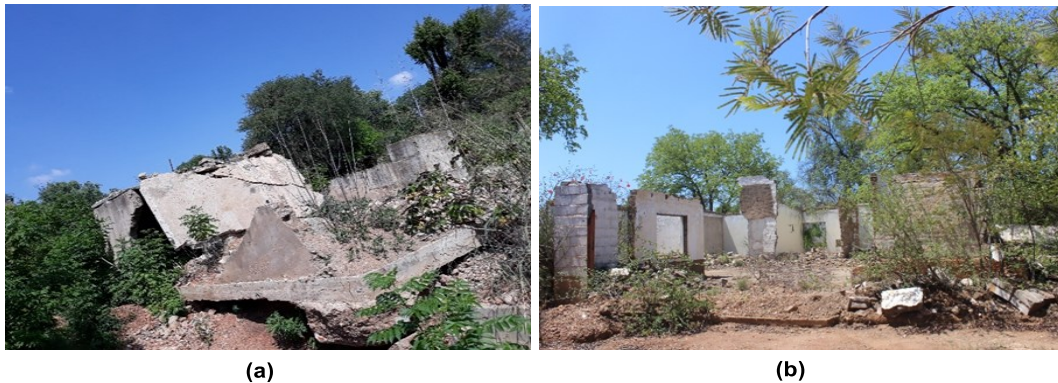
All the buildings found at Louis Moore were approximately 2.8 m high, they had cracks and unstable walls which can fall any time. Dilapidated buildings in Louis Moore and Klein Letaba mine sites occupied an estimated area of 1000m² and 1200m² respectively. A double storey building around Klein Letaba mine was found with walls that attained an approximate height of 5.5m. This was linked to environmental impacts as the area occupied by these buildings hinder vegetation growth and other economic land uses. It is also important to note that these mines are found near the surrounding communities, as such, children enter these buildings

Figure 4. 6: The collapsed (a) and (b) standing dilapidated buildings in abandoned mine sites

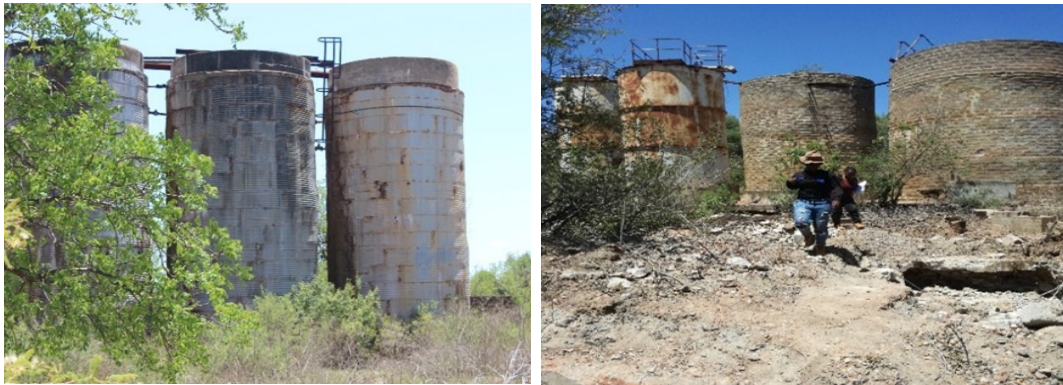
Abandoned silos of approximately 12m in height and 4m in diameter were found in the mine sites as shown in Figure 4.7. These silos have cracks and rust on their walls. Several shallow excavations by illegal miners around these structures were evident. This may weaken the foundation of these structures, causing structural failure and bending and may eventually collapse. Moreover, these structures ruin the aesthetics of the area, and the land they occupy hinders vegetation growth which negatively affects biodiversity in the area.

Figure 4. 7: Abandoned silos and excavations by artisanal miners around these structures

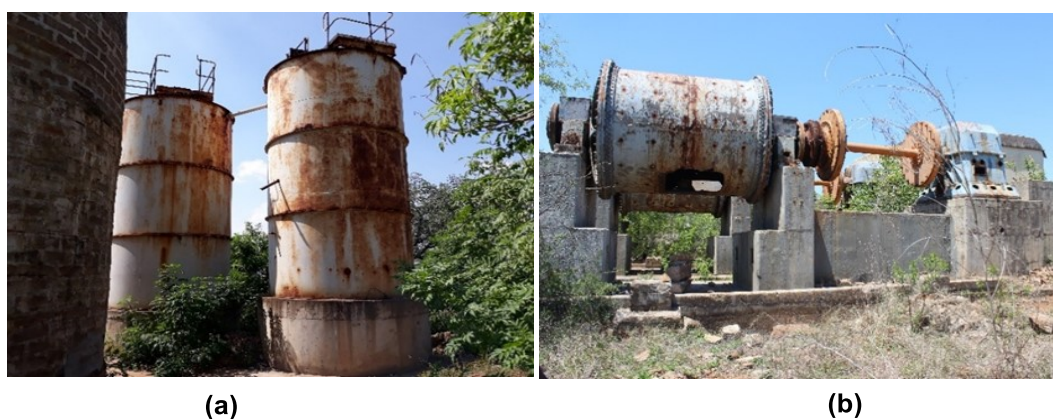
Agitation tanks and ball mills are among the abandoned machinery and processing plant facilities found at Louis Moore and Klein Letaba mines (Figure 4.8). The agitation tanks were mounted on 2m high concrete stands designed to support the tanks. The tanks were estimated to be 4m high and 2m wide. Illegal miners believe there are residues of gold in and around these facilities, as such they dig around old processing facilities to recover the residues. Old processing plants are linked to spillages that can cause health and environmental issues since they are corroded and may have cracks/small openings. Due to the excavations dug by illegal miners, the ground around these structures is unstable, as such, these features are prone to failure or collapse. This poses risks of injury and/or death to the illegal miners, trespassers, and anyone in contact with these structures.

Figure 4. 8: Abandoned (a) agitation tanks and (b) ball mills at the mine sites

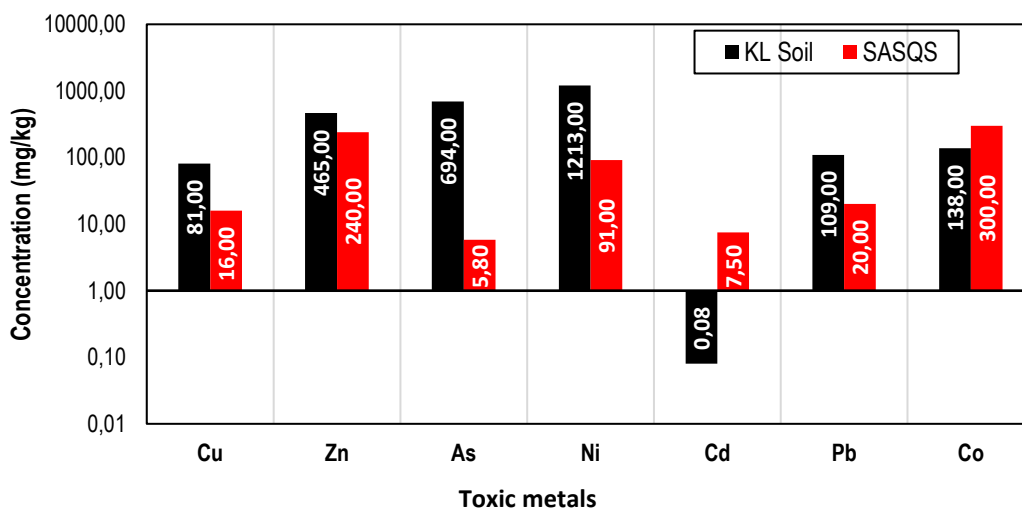
The concentration of Cu, Zn, As, Ni, Cd and Pb at Klein Letaba was more than 2 times higher than the threshold concentration in natural soils, with As concentration of 694 mg/kg and this being 120 times more than the SASQS of 6 mg/kg (see Figure 4.10). This showed that the soil around the mine site is strongly contaminated by these elements.

Figure 4. 10: Concentration of toxic metals in the soil and the SASQS

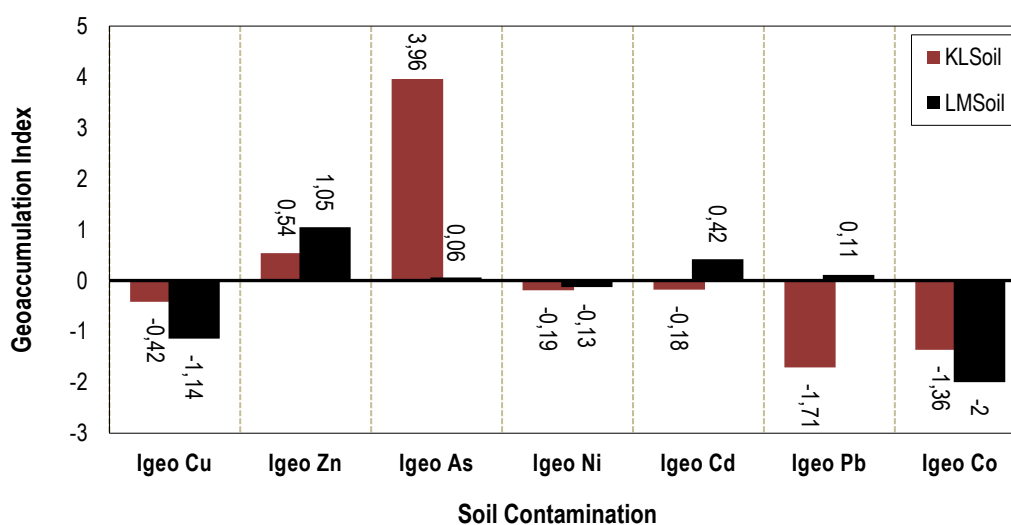
The calculated results of Igeo in the soil around Louis Moore indicated that As, Cd, and Pb fell in Class 1, thus suggesting that the soil is uncontaminated to moderately contaminated by these metals. Zinc was found to be in Class 2 with an Igeo value of 1.05, whilst Cu, Ni and Co Igeo values were found to be in Class 0. In this case, the Igeo values of -0.13 to -2 suggests that the soil at LM is not contaminated by these metals. It can be concluded that KL and LM soil is not contaminated by Cu, Ni and Co. However, KL soil is moderately to strongly contaminated by As and Zn.

Figure 4. 11: The metal pollution of the soil from the abandoned mine sites

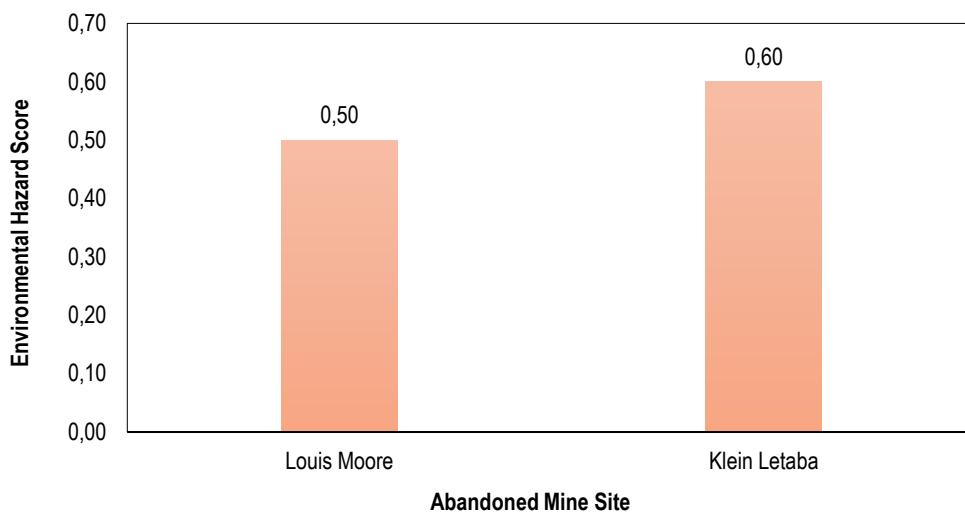
The environmental hazard scores obtained for old mine buildings was 0.50 at Louis Moore and 0.60 at Klein Letaba (Figure 5.4), indicating low environmental risks that may result from this feature. The buildings in both sites are scattered, dilapidated, filled with cracks and some are collapsing. This may lead to alteration of the natural landscape and has visual and aesthetic impacts. These features may also hinder vegetation growth in these areas, thus presenting environmental impacts and loss of biodiversity.

Figure 5. 4: Environmental hazard scores for abandoned mine buildings at the mine sites

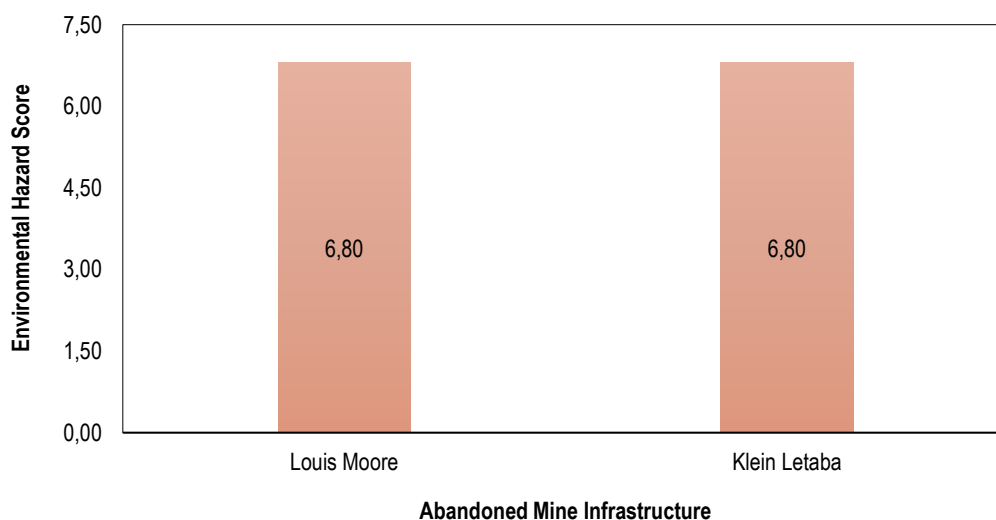
Environmental hazards associated with old processing plants or abandoned mine infrastructure were computed holistically because the features shared similar potential environmental risks and impacts, as such they were not isolated. Old processing plants have a potential to cause environmental impacts through soil contamination by toxic metals that spilled or leaked when the mine was operational, and these metals were leached into the soil. This may lead to pollution of nearby water systems or sources and may also affect vegetation growth. These features were scattered around both mines and affect the aesthetics of the area. Moreover, these structures hinder vegetation growth and limit biodiversity as nothing grows where these features are mounted. The computed environmental hazard score for old processing plants was 6.80 for both Louis Moore and Klein Letaba as shown in Figure 5.6, suggesting moderate potential environmental risks relating to these mine features.

Figure 5. 6: Environmental hazard scores for abandoned infrastructure

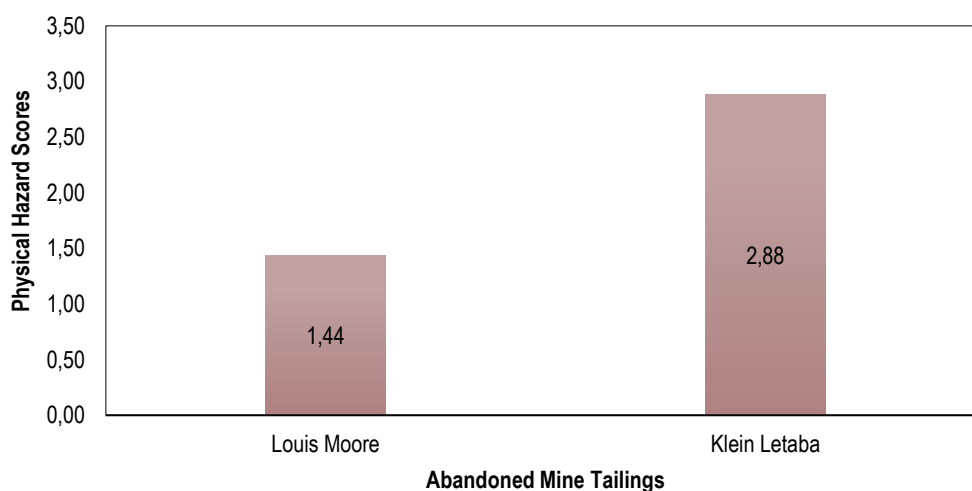
The risk of physical injury may result from failure of steep slopes of the tailings dumps, thus posing health and safety impacts. The physical hazard score for tailings at Louis Moore was 1.44 and 2.88 for Klein Letaba as shown in Figure 5.7. According to the ranking criteria developed, physical risks or hazards posed by the dumps are low for the two mine sites.

Figure 5. 7: Physical hazard scores computed for Louis Moore and Klein Letaba

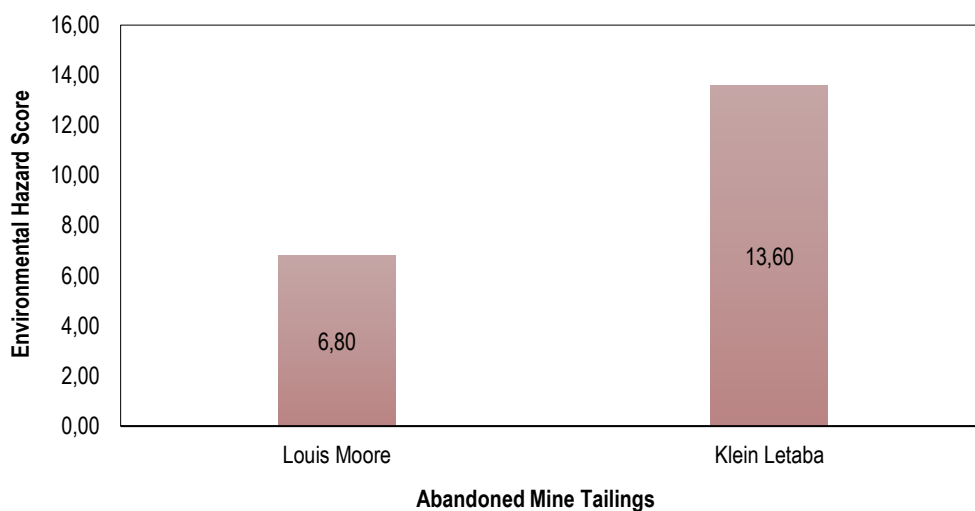
The environmental hazard score for abandoned mine tailings was 6.80 at Louis Moore and 13.60 at Klein Letaba, suggesting moderate potential hazards and risks at Louis Moore and extremely high potential risks at Klein Letaba as shown in Figure 5.8. The evaluation of environmental hazards for abandoned mine tailings in the two mines showed high erosion rates evidenced by dense network of gullies on the tailings dumps given that the mine tailings are neither protected nor closed. This may also lead to dispersion of toxic particles from the

According to the ranking criteria developed in this study, environmental risks resulting from mine tailings at Louis Moore are high and extremely high at Klein Letaba, given that there are two abandoned mine tailings at Klein Letaba and one at Louis Moore.

Figure 5. 8: Environmental hazard scores for abandoned mine tailings

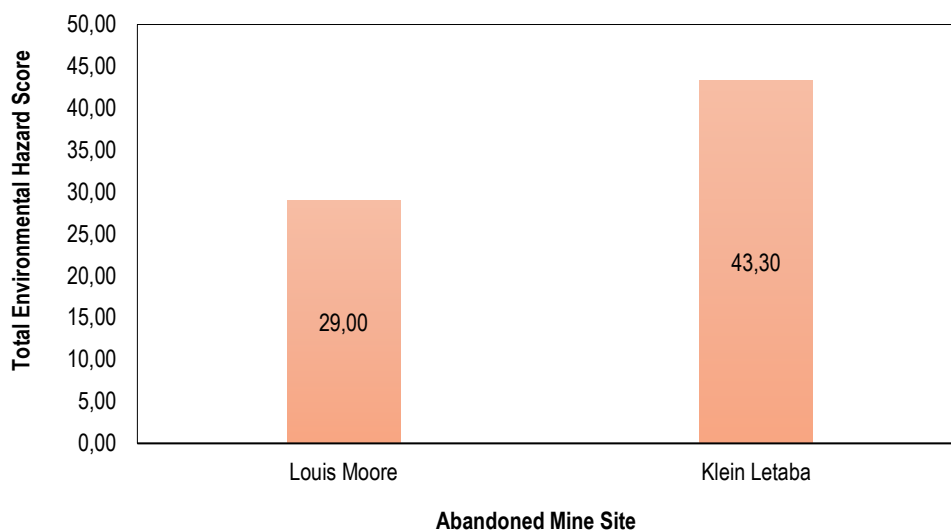
The overall environmental score for abandoned mine features at Klein Letaba was significantly higher than that of Louis Moore as shown in Figure 5.10. This indicated that environmental hazards are severe at Klein Letaba when compared to Louis Moore. Therefore, abandoned mine features at Klein Letaba must be prioritized for rehabilitation over Louis Moore.

Figure 5. 10: Total Environmental Hazard Scores computed for Klein Letaba and Louis Moore
