**THE ASSESSMENT OF WATER SUPPLY SYSTEM EFFICIENCY AND  
WATER QUALITY IN STANDERTON, LEKWA MUNICIPALITY,  
MPUMALANGA, SOUTH AFRICA**

**A dissertation submitted to the Department of Earth Science, Faculty of  
Science, Engineering and Agriculture at the University of Venda in fulfilment  
of the requirements for Master of Earth Science in Hydrology and Water  
Resources**

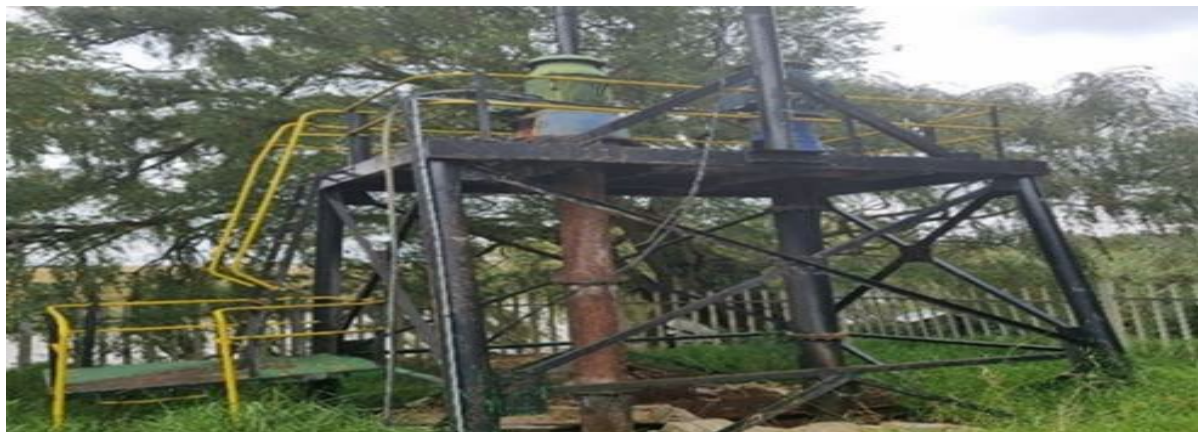
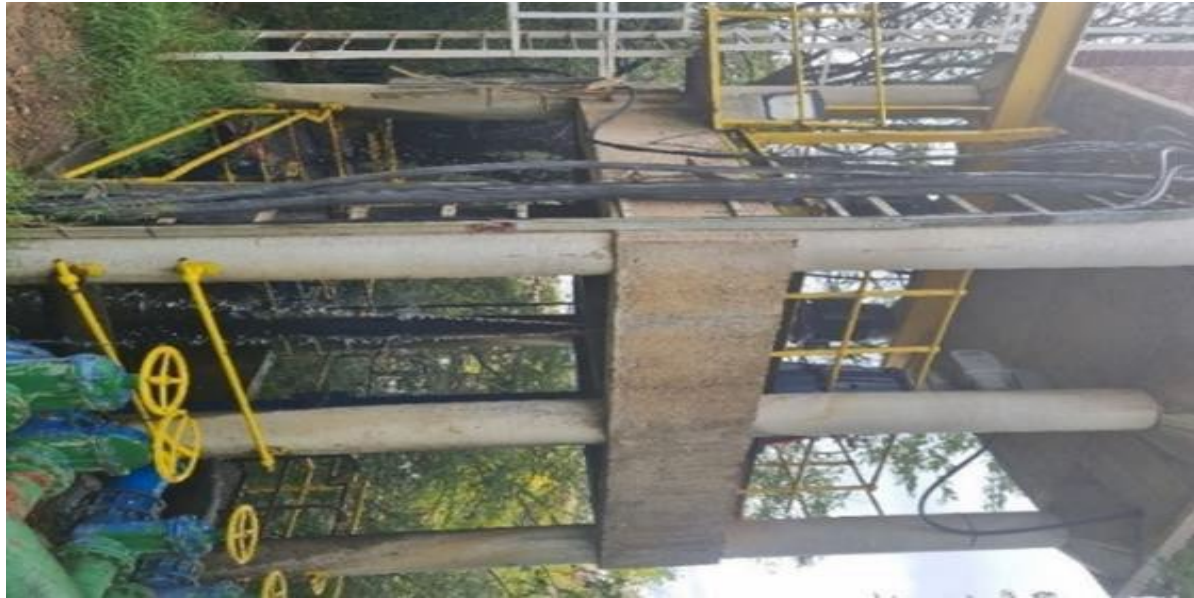
**Figure 4.1: Raw water pumps 1 and 2 closer to Vaal River**

The Standerton water supply system includes two raw water pump stations, Pump Station 1 and Pump Station 2 (Figure 4.1). At Pump Station 1, five of the original six pumps are currently operational, while one is undergoing repairs. Pump Station 2 is non-operational although one of its two pumping units has been replaced, it has not yet been commissioned. Presently, the system abstracts approximately 43 ML/d of raw water from the source. The Standerton Water Treatment Plant (SWTP) is designed to treat up to 37 ML/d. Recent renovations have focused on upgrading the sand filtration units to improve treatment efficiency and the sand media in all filters is currently being replaced. Treated water is conveyed through four bulk pumping mains which serve both residential and industrial users. These mains supply water to four reservoir sites, each comprising two reservoirs. The current water demand is approximately 45 ML/day, which exceeds the plant's design capacity, highlighting a potential risk to sustainable service delivery.

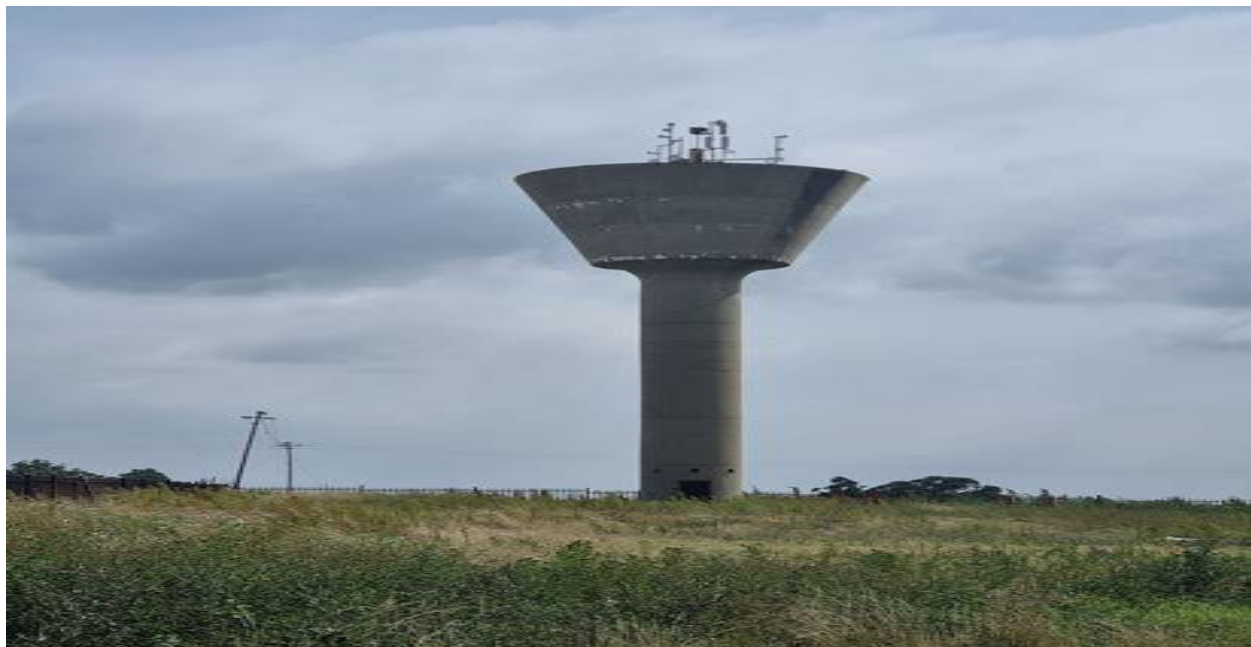
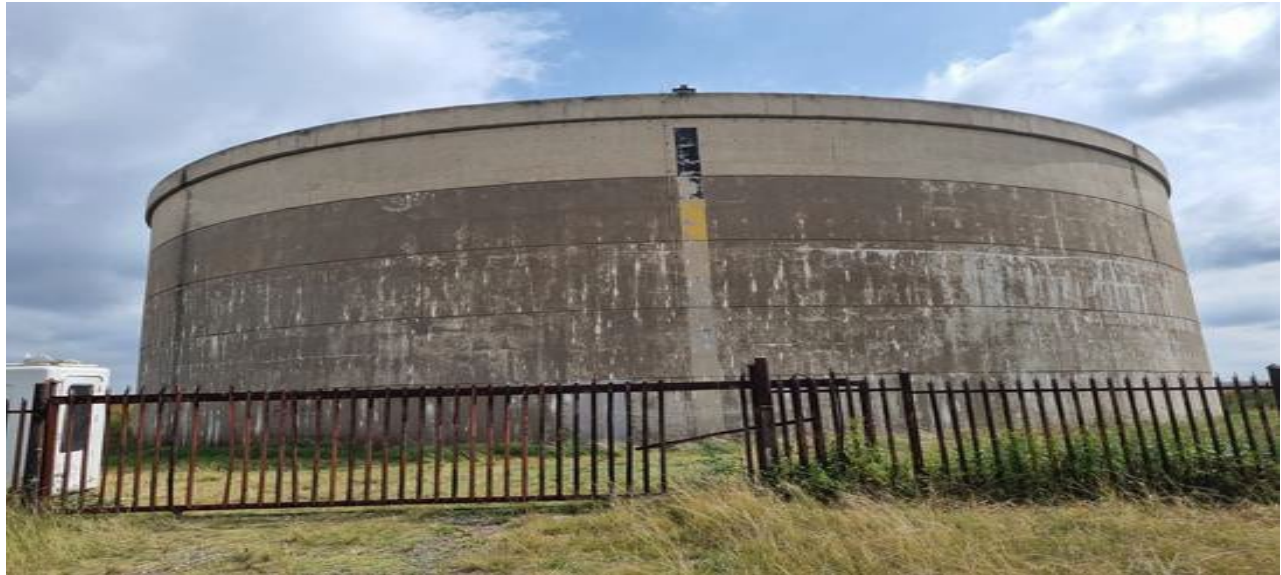
**Figure 4.4: Rising Main to Concor Reservoir**

The pumping system consists of five units, including three main pumps and two pumps on duty, which supply water through the rising main to the Concor Reservoir bulk line (Figure 4.4). Currently, both backup pumps are under repair and not operational. The rising main to Concor Reservoir is a 5 km long asbestos cement (AC) pipeline with a diameter of 300 mm. The presence of a single air valve along the pipeline limits the system's capacity, reducing the delivery rate to 5.45 ML/d instead of the design capacity of 8.45 ML/d. This pipeline supplies two reservoirs at Concor, which have a combined storage capacity of 10.5 ML/d.

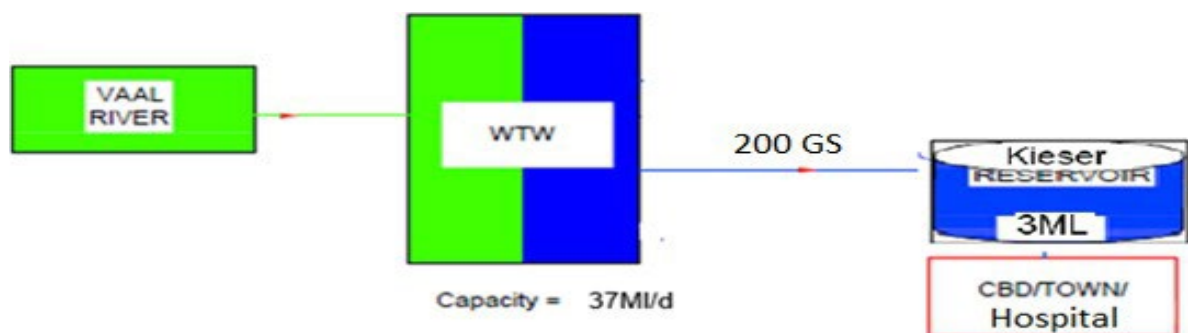
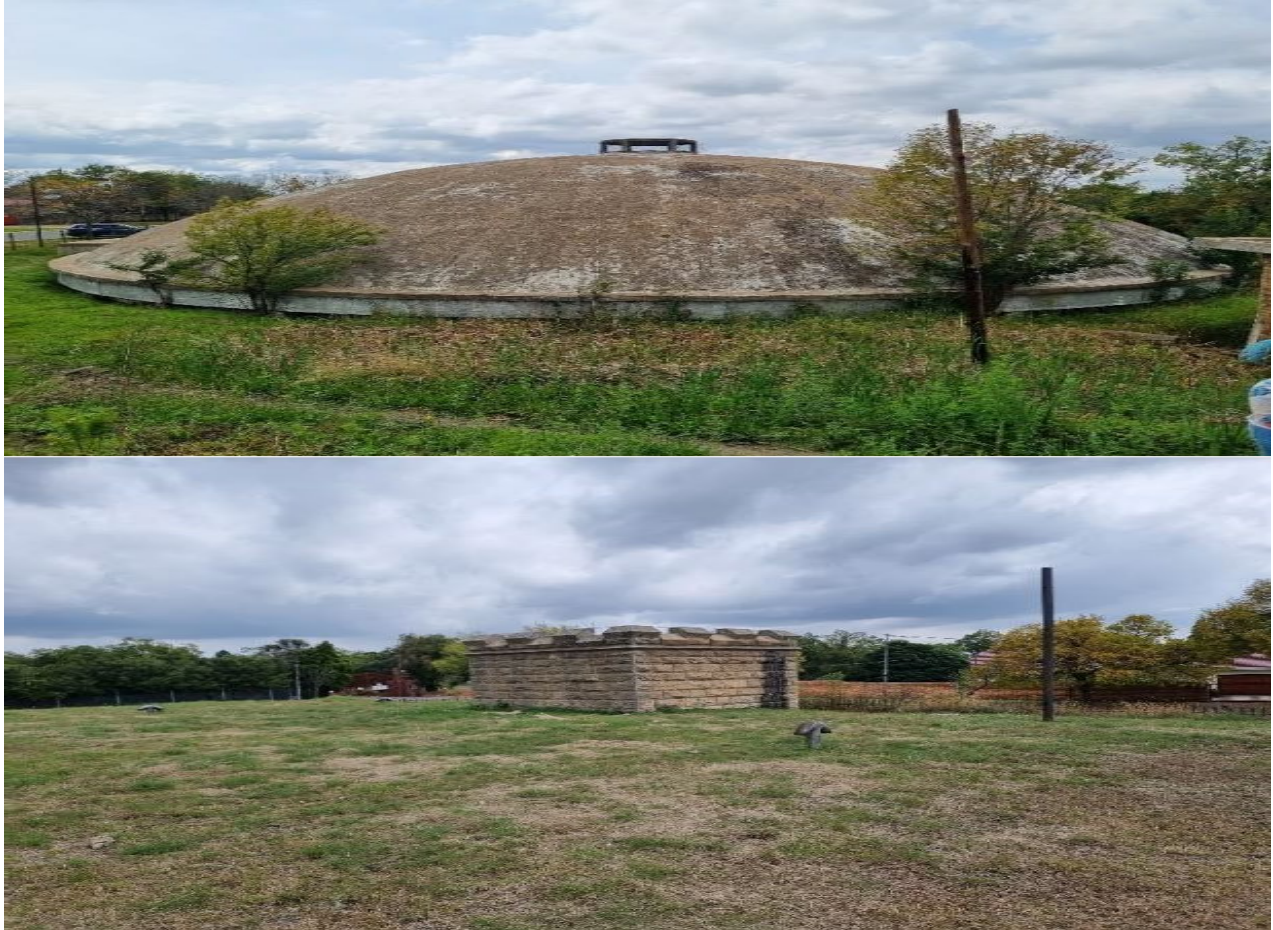
**Figure 4.5: Kieser Reservoir**

The Kieser Reservoir bulk line is supported by two pumping units, one of which is currently non-operational and serves as a standby pump (Figure 4.5). Water is conveyed through a 2.89 km rising main constructed of 200 mm diameter galvanized steel pipe to the Kieser Street reservoirs. These two reservoirs have a combined storage capacity of 3 ML/d and supply water to key demand areas, including the hospital, central business district (CBD), and surrounding residential zones, which collectively require approximately 8 ML/d. However, both reservoirs are experiencing leakage issues, compromising storage efficiency and contributing to water losses within the supply system. The existing leaks exacerbate supply demand imbalances and highlight the need for urgent maintenance and infrastructure rehabilitation to ensure reliable water delivery to these critical service areas.

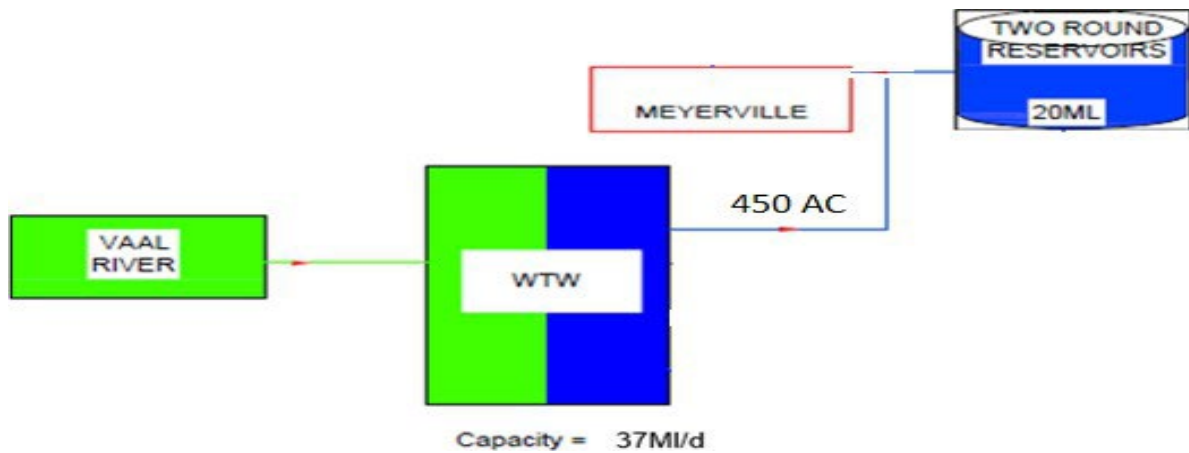
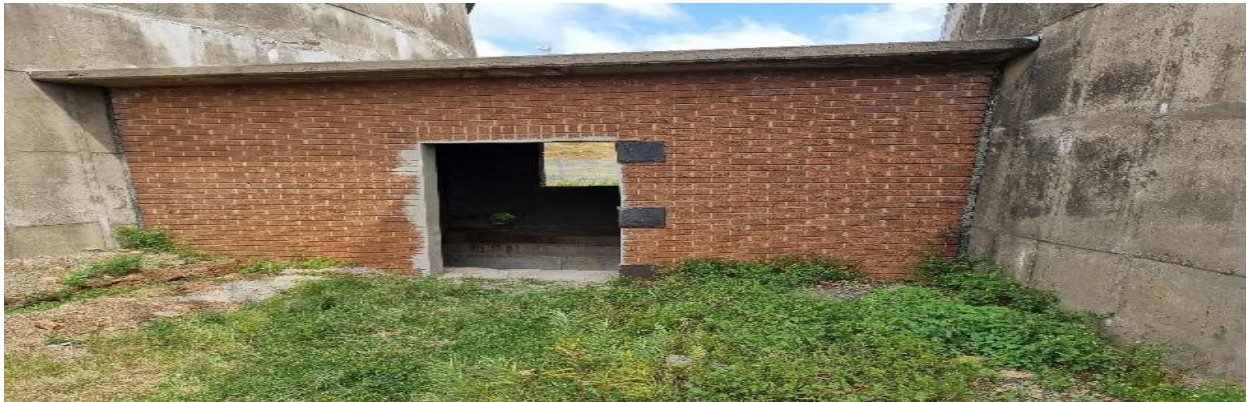
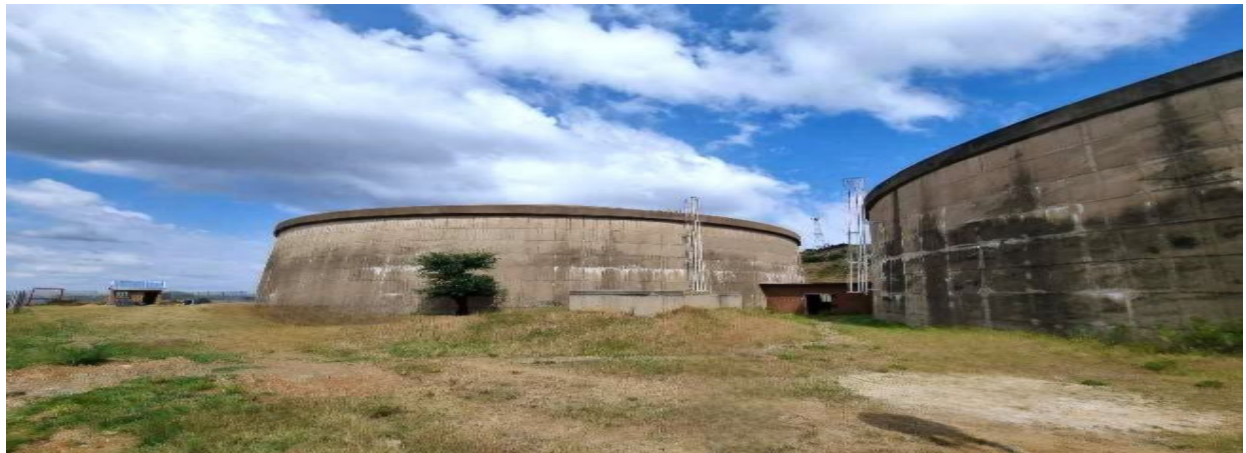
**Figure 4.6: Two Round Reservoir (New Standerskop) Bulk Supply line**

The Standerskop reservoir bulk lines are supported by four pumping units, including one standby unit connected via cable (Figure 4.6). The system features a 6.4 km rising main constructed from a 450 mm diameter asbestos cement (AC) pipeline, which supplies water to the New Standerskop reservoirs while traversing various suburbs and the town of Standerton. Along this pipeline, there are approximately thirteen off-takes that distribute water into the local network. These include a 200 mm diameter main feeding Meyerville and a 400 mm diameter main serving Sakhile Extension 4. Due to the current system configuration, potable water supply across the area is unevenly distributed, the bulk rising main functions simultaneously as a pumping main and as a bulk distribution pipeline. The two New Standerskop reservoirs each have a storage capacity of 10 ML/d but are currently compromised by leakages, which reduces effective storage capacity and contributes to water losses. Addressing these infrastructure issues is critical to improving system

reliability and ensuring equitable water supply.

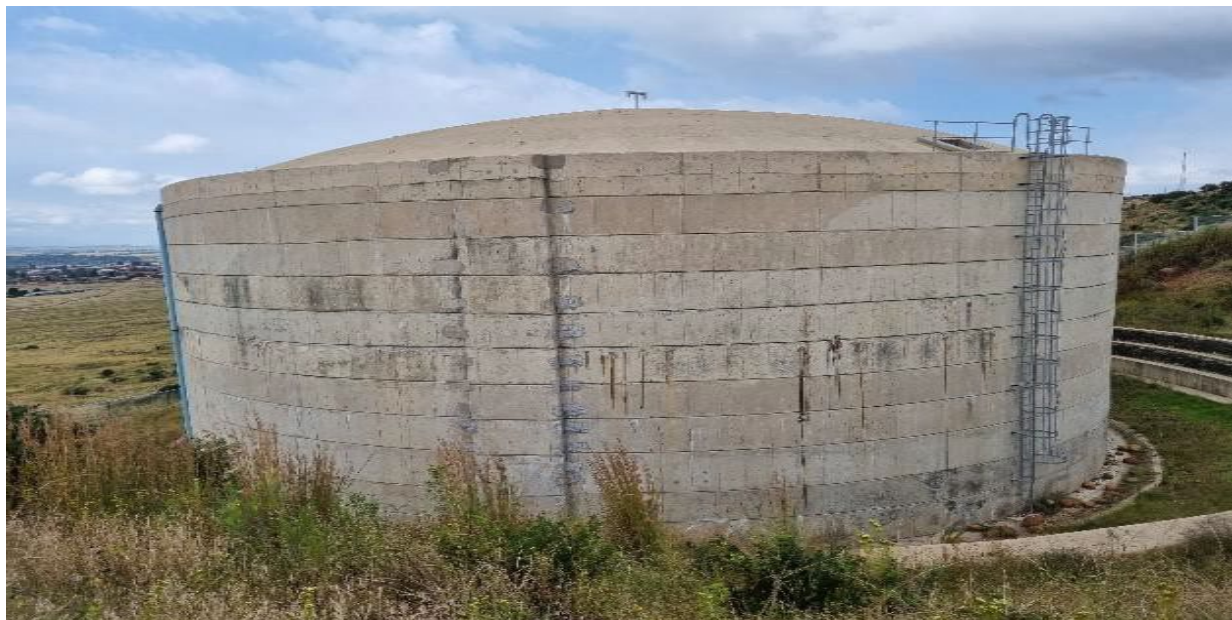
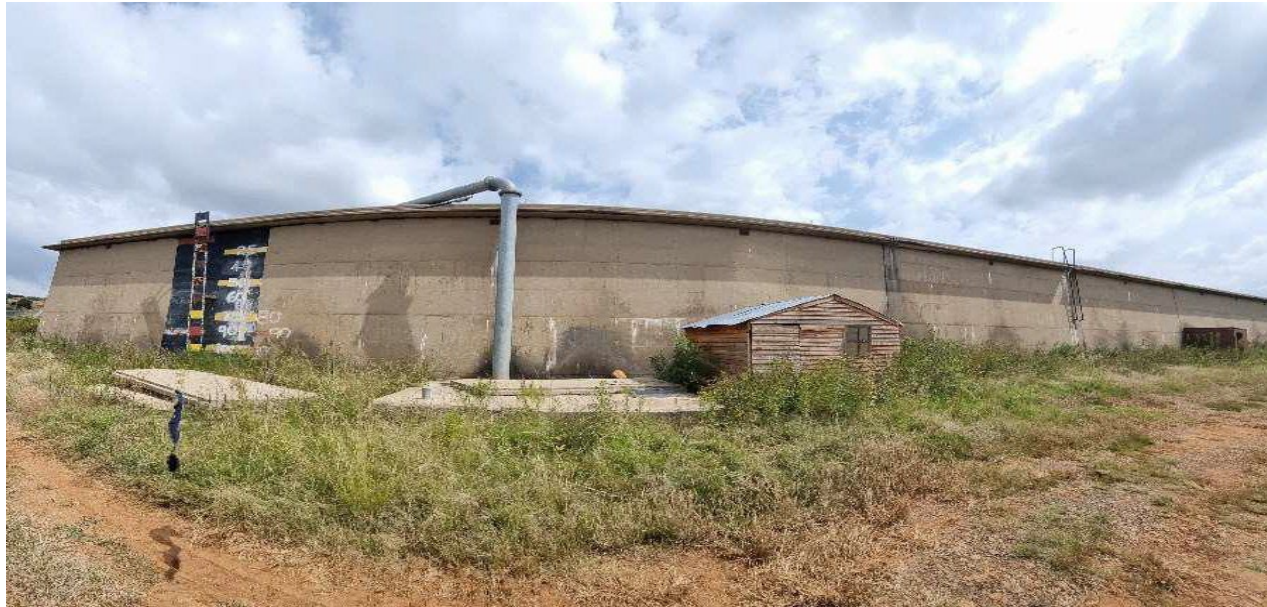
**Figure 4.7: New round and old square reservoir**

The bulk supply to the New Round and Old Square reservoirs is supported by three pumping units, of which only one is currently operational. Water is conveyed via a 1.5 km rising main composed of 300 mm diameter asbestos cement (AC) pipe to the Showground where the pipeline splits into two branches: a 315 mm diameter uPVC pipeline leading to the Old Square reservoir and a 300

mm diameter galvanized steel pipeline that also serves as a distribution main through several off-takes (Figure 4.7). The total length of the pipelines from Showground to the reservoirs is approximately 5.8 km. The two reservoirs have a combined storage capacity of 19 ML/d. However, the Old Square reservoir is compromised due to leakage, reducing its effective storage capacity and contributing to water losses in the system. Meanwhile, the New Round reservoir remains out of service as it was never commissioned by the Gert Sibanda District Municipality, further limiting the available storage and distribution capacity.

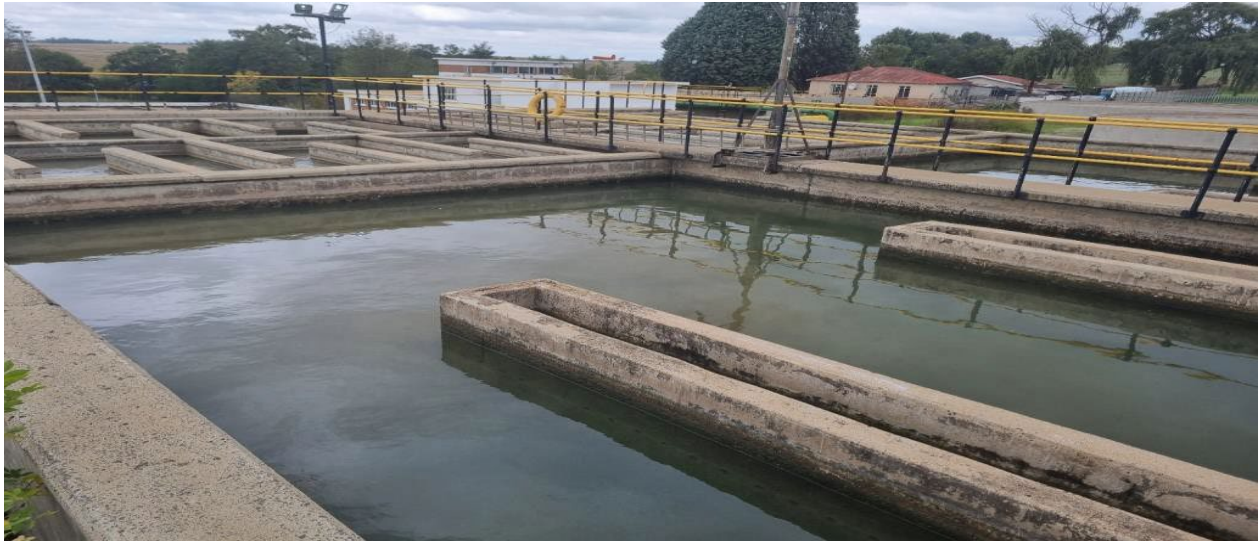
**Figure 4.19: Standerton Water Treatment Works**

infrastructure. The study identified numerous infrastructure-related issues affecting Standerton's water supply system. While a small portion of the bulk pumping mains consist of steel pipes, the majority are made of asbestos cement, which is prone to frequent failures. These pipe bursts regularly disrupt water supply to communities and result in substantial water losses.

Additionally, the presence of multiple offtakes along the main supply line from the Standerton Water Treatment Works (WTW) to the various reservoirs has negatively impacted pipeline capacity. Ageing pipelines have led to reduced hydraulic pressure and increased leakage rates, further exacerbating the inefficiency of the water distribution system. These infrastructural and operational deficiencies present major obstacles to achieving long-term sustainability and reliability in the provision of potable water in Standerton.
